Inspection / Replacement Nose Gear Rubber Damper

MANDATORY

- **Gyroplanes Calidus**
- Serial numbers (Werk-Nr.) C00149 to C00235
- Gyroplanes Calidus where a replacement of the rubber damper has been accomplished until and including August 2012

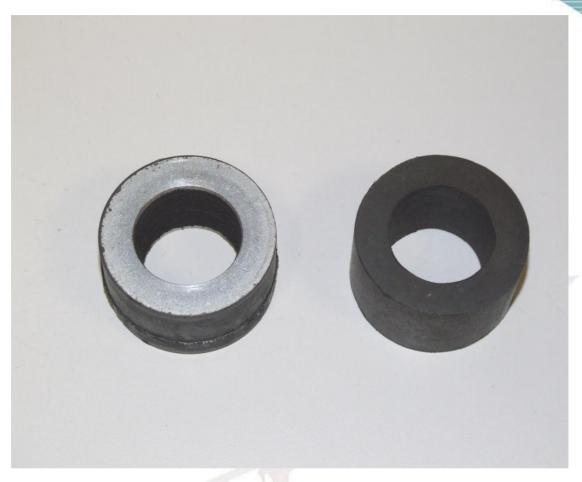
When operated on rough ground with high load on the nose gear the rubber damper of the nose gear may slip over the stop disc, causing the nose gear to 'retract' and disengage from its bearing seating. This will cause a loss of tension in the nose wheel control cables which will render the aircraft difficult to control with the nose wheel on ground.

Determine the configuration state of the rubber damper. In case a rubber damper with volcanized metallic discs (see Fig. 1) is installed no further action is required. Otherwise the nose gear rubber damper has to be replaced as instructed below.

Fig. 1: Rubber damper with volcanized metallic discs

,old' rubber damper (to be replaced)

Inspect the configuration state of the rubber damper and replace with improved component, if necessary.

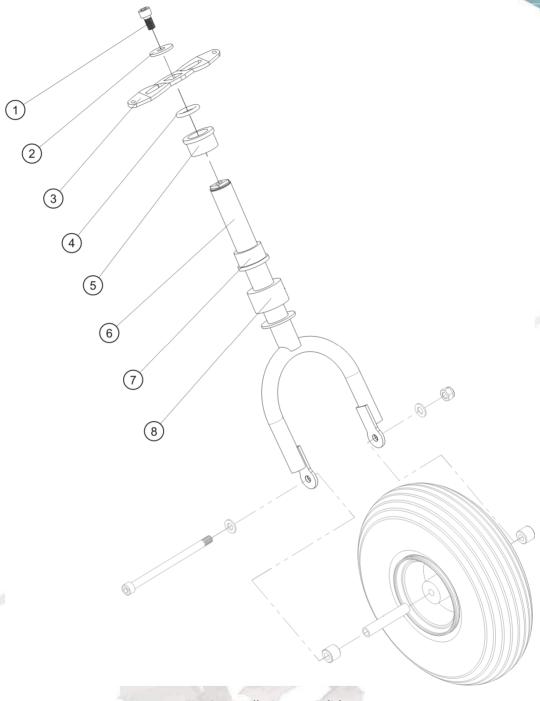
Fig. 2: Installation on Calidus

- 1. Unload/lift nose gear. In order to do so lift at the jacking point at the fuselage belly right behind nose wheel, using a soft non-slip lining.
- 2. Remove bolt (1) and washer (2).

- 3. Pull control linkage (3) from square shaft. Caution: Hold wheel assembly and prevent from falling out.
- 4. Pull out front wheel assembly. Note that bushings (5) and (7) remain in the fuselage.

- 5. Remove rubber damper (8) and mark unserviceable.
- 6. Install new rubber damper.
- 7. Apply AG-GRS-01 on the tube, but not on the threads. Install nose wheel assembly in reverse order. Make sure wheel assembly is installed so that angled fork faces forward, i.e. extends to the front.

- 8. Install control linkage (3) and washer (2).
- 9. Apply AG-BAS-02 to inner threads of nose gear assembly and install bolt (1).
- 10. Torque bolt (1) with 40 Nm.

- 11. Perform a functional test of the nose wheel steering with the nose wheel normally loaded.
