Title: Pneumatic Clutch III (2017) – Pressure Disc Inspection		
AG-SB-2018-05-B-EN		Compliance Category:
Applicability		A – MANDATORY
Aircraft type & model: All MTO2017 and all Calidus/Cavalon with rotor head III fitted	Affected Serial number(s): All MTO2017 and all Calidus/Cavalon with rotor head III fitted	B – RECOMMENDED
The maintenance manual to be referenced is this stated or subsequent issue.		C – OPTIONAL
As per AutoGyro website		
<p>This form is the response from AutoGyro GmbH either against a problem found in the product in service requiring a containment or rectification action, or as service information for aircraft modification incorporation. For help, contact AutoGyro on 49(0)5121 88056-00, or email airworthiness@auto-gyro.com.</p>

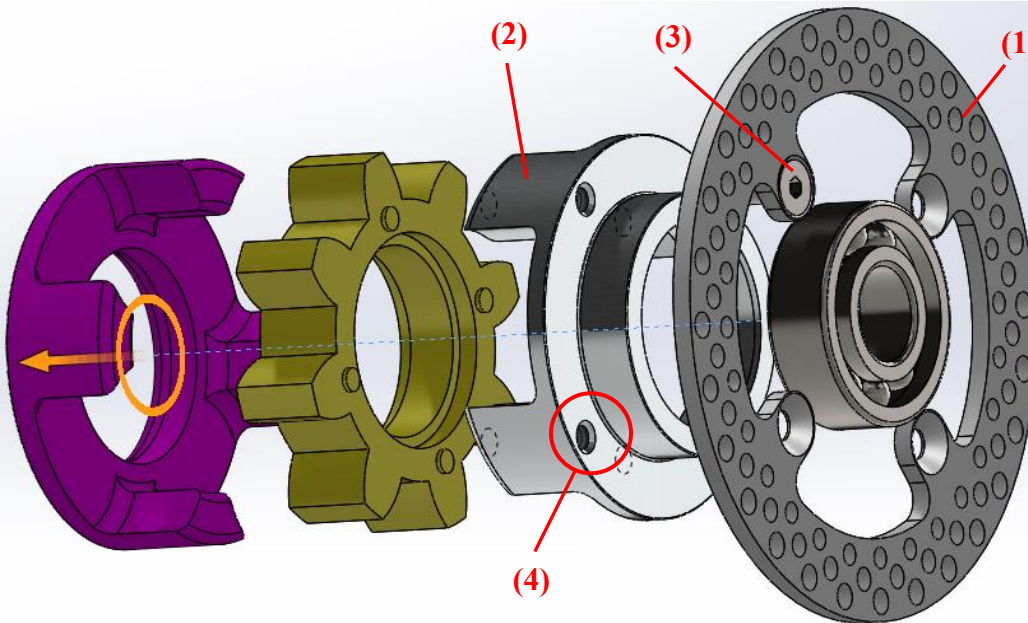
Fig. 1 - Pressure Plate Assembly (31713)

It has been found that the threaded holes in the first batch of pneumatic clutch III (2017) Pressure Plate front (2) are not sufficiently countersunk to accept the countersunk screws securing the Pressure Disc PKII (1). The effect is that the screws are unable to properly clamp the disc and plate together, possibly leading to looseness, rattle noise, and wear of this connection.

1. Remove any cowlings required to gain access to the clutch assembly.
2. Remove the pneumatic clutch from the engine in accordance with AMM job card 63-11-10 4-1.
3. Remove the center screw retaining the pressure plate assembly (31713) to the clutch in accordance with AMM job card 63-11-10 8-1 part 4.
4. Remove the pressure plate assembly (31713) from the clutch and remove the 4 countersunk screws (3) securing the pressure disc (1) to the pressure plate front (2).
5. Inspect for signs of rotational movement of the pressure disc (1) on the pressure plate front (2), and/or elongated holes in the disc (1). If damaged, replace (article 23604).
6. Inspect the complete clutch assembly for any further damage and replace any affected parts (eg. 31713 Pressure Plate Mounted).
7. Inspect the pressure plate front (2) and ensure that the threaded holes (4) are countersunk to a

- depth of 1mm with a 45° countersink. If not, re-work with a suitable countersink tool.
8. Re-assemble the clutch in reverse order of disassembly.
 9. Assemble the clutch to the engine in accordance with AMM job card 63-11-10 4-1.
 10. Re-fit any cowlings previously removed.
 11. Ground run the aircraft in a suitably secured area, including a pre-rotation clutch functional check.
 12. Note the SB action within the aircraft documentation.
