Title: Calidus mast bracket replacement		
AG-SB-2022-01-C-EN	Effective Date: 05 APR 2022	Compliance Category:
Applicability		A - MANDATORY B - RECOMMENDED C - OPTIONAL
Aircraft type & model: Calidus	Affected Serial number(s): All; aftermarket repair	
The maintenance manual to be referenced is this stated or subsequent issue.		As per AutoGyro website
This form is the response from AutoGyro GmbH either against a problem found in the product in service requiring a containment or rectification action, or as service information for aircraft modification incorporation. For help, contact airworthiness@auto-gyro.com .

Reason and overview of the Service Bulletin (cause of problem if known)

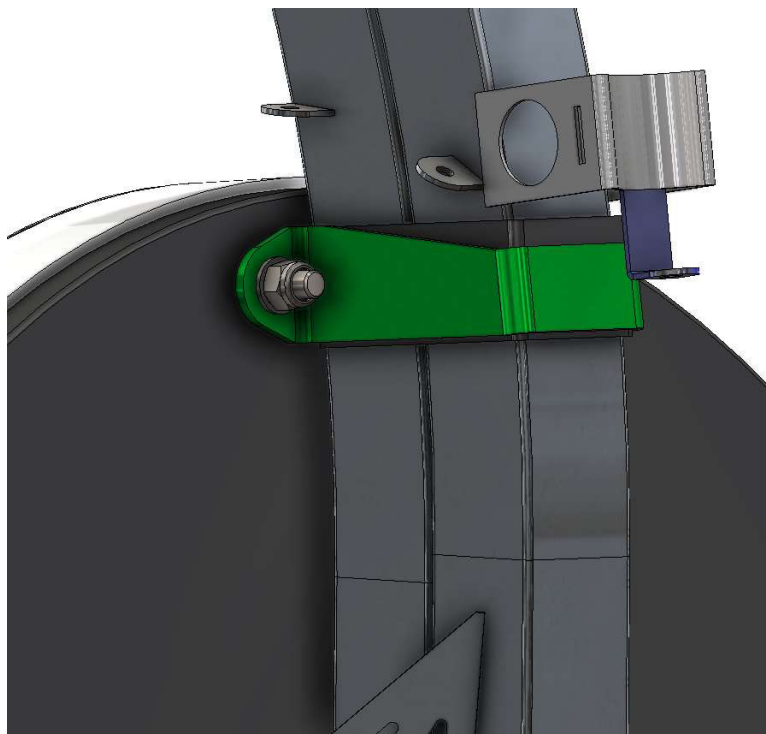
In response to occasional reports of both a crack in the upper mast to body mounting bracket or forward mast in the same area, AutoGyro has developed a repair method to replace the upper mast to body mounting bracket with a separate bracket. This allows mast flexure whilst still providing a secure fixing to the front body. This also allows easy repair without welding, or in-service upgrade.

Solidworks view of the improved attachment between the mast and body.
