Title: Inspection of Rotor head		
AG-SB-2022-09-B-ENR2	Effective Date: 07.10.2022	Compliance Category: A – MANDATORY B – RECOMMENDED C – OPTIONAL
Applicability		
Aircraft type & model: All Cavalon and Calidus with Rotor head III	Affected Serial number(s): All Cavalon and Calidus with Rotor head III	
The maintenance manual to be referenced is this stated or subsequent issue.		As per AutoGyro website
This form is the response from AutoGyro GmbH either against a problem found in the product in service requiring a containment or rectification action, or as service information for aircraft modification incorporation. For help, contact airworthiness@auto-gyro.com .

Reason and overview of the Service Bulletin (cause of problem if known)

The purpose of this SB is to highlight the need for effective pre-flight and service inspection of the weld that joins the rotor head side plate to the roll link bracket.

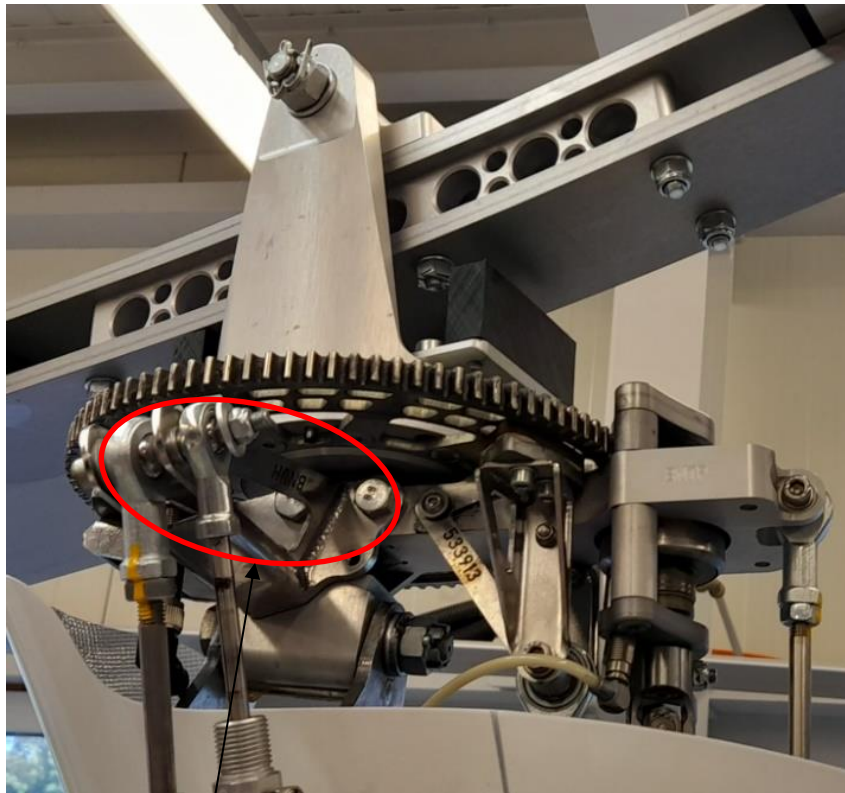
Rotorhead III

Pre-flight inspection requires a thorough review of the rotorhead. Pilot/operators are reminded that this includes the welded connection between the side plates and roll link bracket shown below. This area is open for easy inspection.

If a crack is found, the part is to be replaced in accordance with normal maintenance procedures.

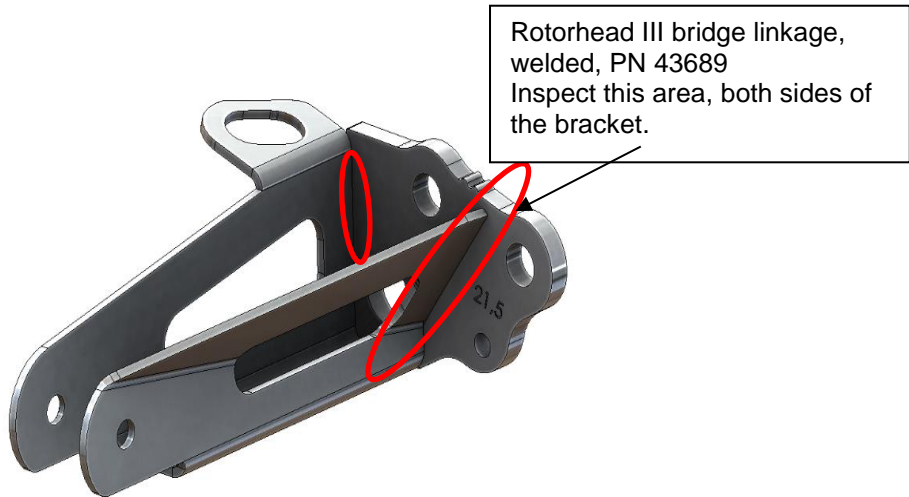
The ringed area indicates the installed bridge linkage

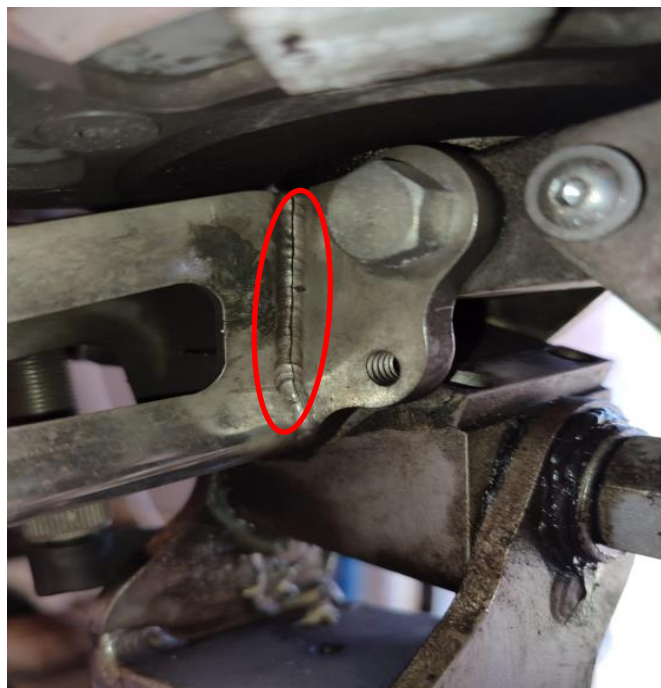
Reason; a small number of 1st generation Rotorhead III Rotor head bridge roll linkage assemblies were found during service inspection to have a weld crack. The inspection in this area is considered to be part of the pre-flight inspection, and the area is easily visually inspectable.

External weld with crack:

This area is readily inspected during pre-flight inspection

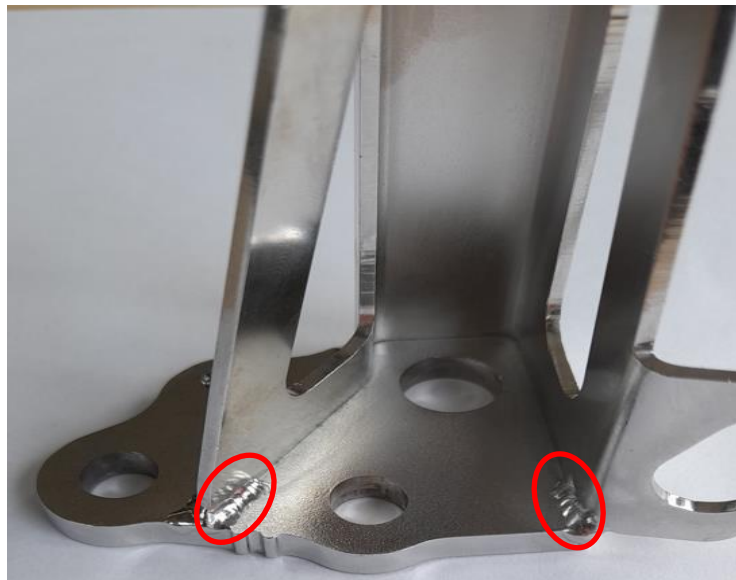
There are two generations of the Rotorhead III Rotor head bridge roll linkage assemblies. The second generation is welded on the inside upper end of the bracket, see photo, and was released in 2019. Only this later generation is available, and is fully interchangeable with the earlier version.

Note: these assemblies are stamped with the size (21.5 and 22.5). If replacing, ensure that the correct size is fitted!

Replacement parts if required
 45966, Rotor head bridge roll linkage 22,5 welded (Cavalon)
 43689, Rotor head bridge roll linkage 21,5 welded (Calidus)
