# AG-MI-1302-EN – Pre-Rotator Clutch

Cavalon Serial Number (Werk-Nr.) V00037 up to V00115

Inspection of 'Pre-Rotator Clutch / Pneumatic Clutch III', examination of assembly-caused clearances

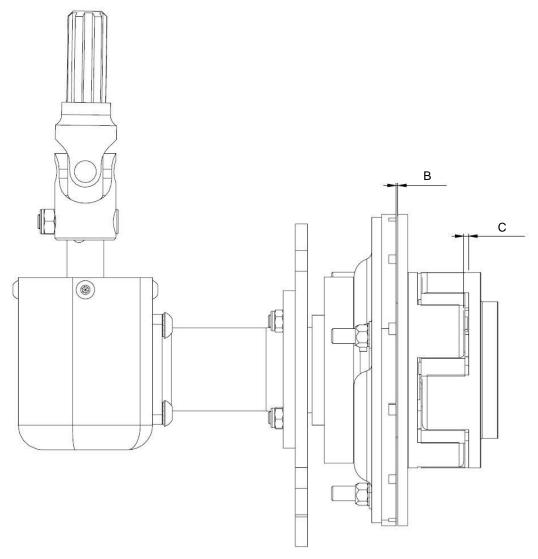
Fig. 1 - Pneumatic Clutch III

Within quality checks an incorrectly assembled coupling driver were noticed.

- 1 Measure clearance (Fig. 1 / B) with feeler gauge. Clearance between clutch lining and clutch plate has to be 1.0 1.5 mm.
- 2 Measure clearance (Fig. 1 / C) with feeler gauge. Clearance between inner drive star disc (engine side) and outer drive star claws (clutch side) has to be 1.0 1.5 mm.
- 3 If both point 1 and 2 identified clearances are in the required size range, the test has been completed and the gyroplane is approved.

If one or both clearances do not lie in-between the required measures, the clutch has to be removed and the clearance between magnetic hub of the engine and inner drive star disc (engine side) has to be checked  $\rightarrow$  gap must be checked with a feeler gauge 0.05 mm, feeler gauge should <u>not</u> be possible to stuck inside.

4 If the clearance is ≥ 0.05 mm, the clutch has to be checked by AutoGyro or an AutoGyro-Maintenance Partner. Inner drive star disc (engine side) has to be demounted and to be checked. The threaded end of the crank shaft must be cleaned. Inner drive star disc (engine side) has to be remounted in accordance with the assembly instructions. The assembly instructions can be sourced via the email address <u>K.Stolz@autogyro.com</u>.
