AG-MI-2013-11-B-EN – Retrofit of Heat Protection

Cavalon

MANUFACTURER INFORMATION

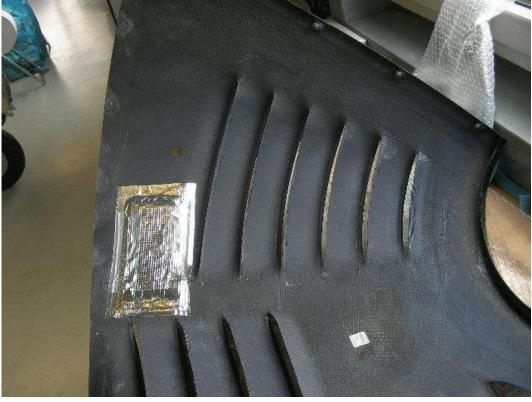
Fig. 1 - Mounted Heat Protection Engine Cowling

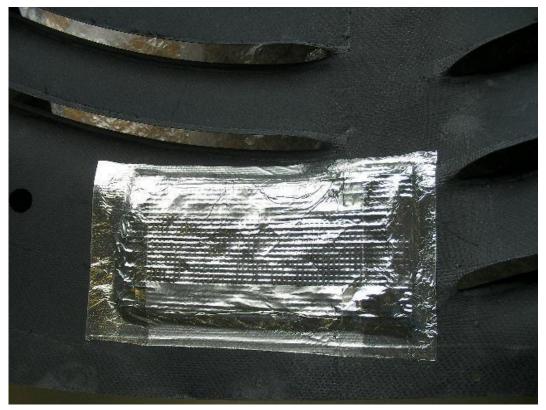
Fig. 2 - Mounted Heat Protection Engine Cowling

- 1 Demount lower cowling
- 2 If 'lower cowling type I' is mounted, mill recess as shown in fig. 3 and deburr recess
- 3 Clean inner side of lower cowling free from dirt and greases
- 4 Fire Protection Pad adhere like in figure 2 and tape outer edges with aluminium tape
- 5 Remount lower cowling

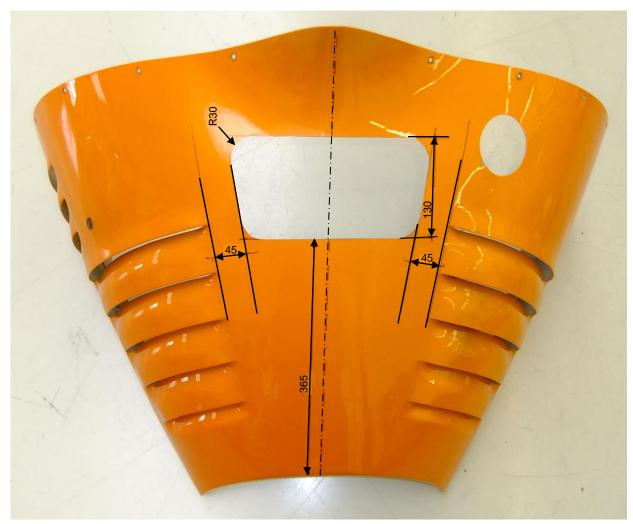
Fig. 3 - Recess in lower cowling type I
