<b>Title: Replacement of exhaust manifold</b>		
<b>AG-SB-2023-02-B-EN</b>	<b>Effective Date: 01.04.2023</b>	<b>Compliance Category:</b>  <del>A - MANDATORY</del> <del>B - RECOMMENDED</del> <del>C - OPTIONAL</del>
<b>Applicability</b>		
<b>Aircraft type &amp; model:</b>  <b>Cavalon 915iS</b>	<b>Affected Serial number(s):</b>  <b>All Cavalon 915iS</b>	
The maintenance manual to be referenced is this stated or subsequent issue.		As per AutoGyro website
This form is the response from AutoGyro GmbH either against a problem found in the product in service requiring a containment or rectification action, or as service information for aircraft modification incorporation. For help, contact <a href="mailto:airworthiness@auto-gyro.com">airworthiness@auto-gyro.com</a> .

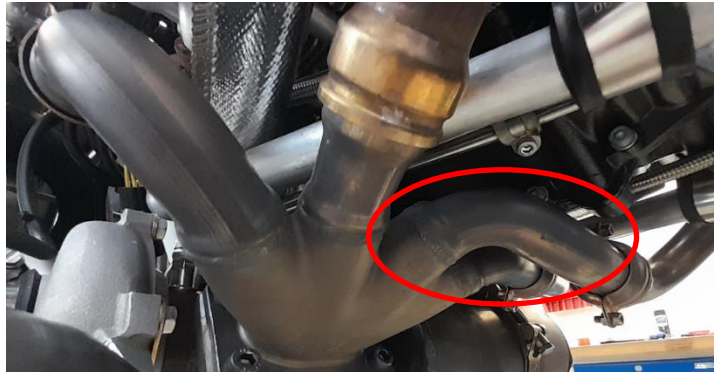
old version part no. 979562:

A number of early generation Rotax 915iS exhaust manifolds were found to have cracked in service. This early generation was superseded in 2021 by a new design, shown in service to be reliable.  
It is recommended to replace the old version.

The exhaust manifold is changed in accordance with the Rotax engine maintenance manual.

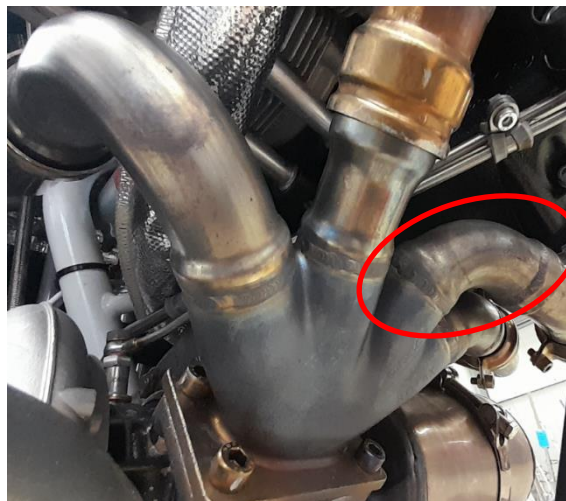
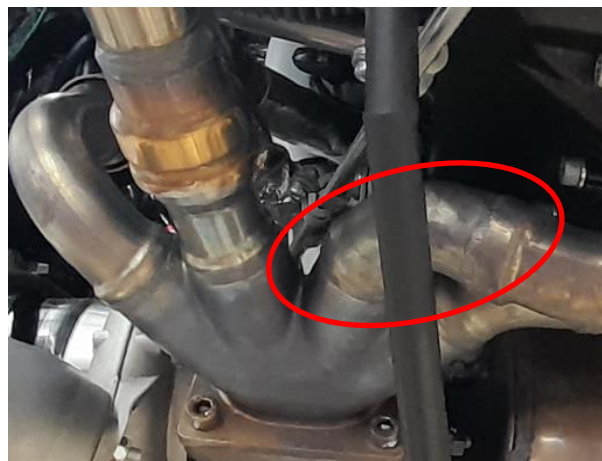
new version part no. 979563:

The difference between both versions is an improved welding at the exhaust connection from cylinder two.

The manifold is Rotax part number 979563.  
AutoGyro provides a kit containing the required service components, part no. 48658, available from the AutoGyro on-line shop.
