Title: Cavalon low-fuel sensor upgrade					
SB No.: 097 Iss1	Related documents MC No: None CCAR No.: None	Compliance Category:  OPTIONAL or			
Applie	RECOMMENDED or				
Aircraft type & model: Cavalon	Aircraft serial Nos. affected: RSUK/CVLN/001 to 012	MANDATORY

# Reason and overview of the Service Bulletin (cause of problem if known)

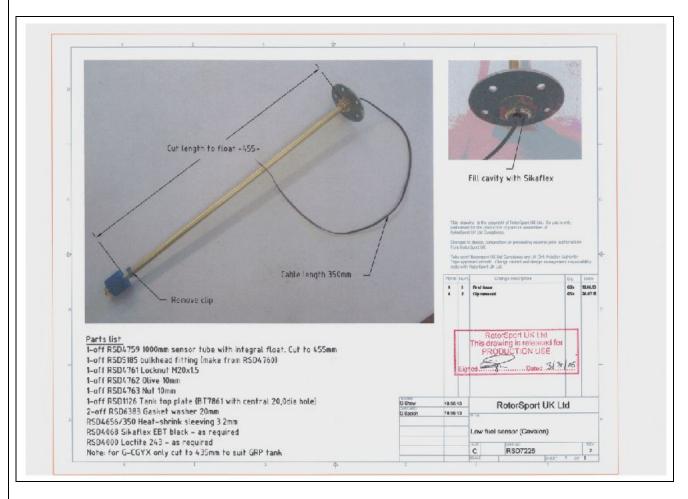
Note that the part number of the sensors is now RSD7226 Iss2.

- 9. Clean-up the flange of the sensor
- 10. Ensuring that no debris falls into the tank, clean-up the mating area on top of the tank
- 11. Apply a bead on Loctite 5331 sealant around the underside of the sensor flange and refit the sensor in its original position.
- 12. Replace the M5 socket screws, removing the threaded stud when the metal inlay is secure. Use a film of Loctite 5331 on the socket screws
- 13. Replace the terminal pins and remake the connector. Fit a safety cable tie to the connector and cable-ties as required to the wiring harness
- 14. Replace the fuel-tank hatch, the comms panel and centre cover.
- 15. Turn on the keyswitch and check that the low fuel lamp is on. Add 7 litres of fuel, and recheck the light should be off.
