Title: Cavalon fuel-tank inlay ring							
SB-109 Iss1	Related documents Modification: MC-347 CCAR No.: None	Compliance Category: OPTIONAL or					
Appli	RECOMMENDED or						
Aircraft type & model: Cavalon	Aircraft serial Nos. affected: RSUK/all prior to CVLN/018	MANDATORY					
The maintenance manual to be referenced is this stated or subsequent issue.		RSUK0288 Iss: 3

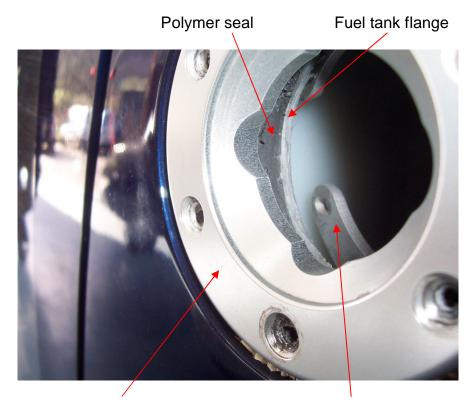
Filler cap mounting plate

Inlay plate under installation

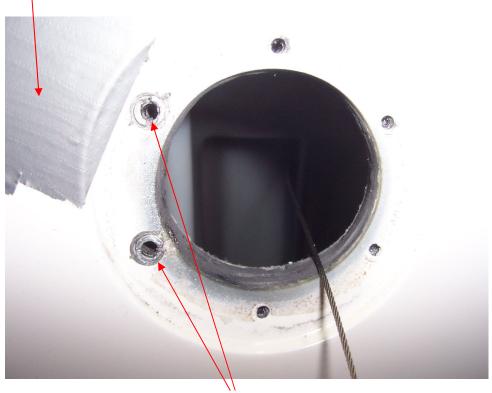
Two rivnut heads slotted for drilling

2. The two most fwd screw positions do not pass into the fuel tank void but into rivnuts secured in the body moulding. These must be carefully and progressively drilled-thru 4.1mm diameter. If the drill bites into the rivnut and causes it to spin in the body the fuel cap mounting plate must be removed completely by prising it off the cork gasket between it and the body.(The gasket is bonded in place with Loctite 5331 sealant). The rivnut heads may then be slotted (using a Dremmel or similar tool) to enable the rivnut heads to be held still during drilling.
