RotorSport UK Ltd Service Bulletin (Permit)

Title: Replacement oil pump adaptor		
SB-113 Iss1	Related documents Modification: MC-None CCAR No.: None	Compliance Category: OPTIONAL or RECOMMENDED or MANDATORY
Applicability		
Aircraft type & model: MTOsport, Calidus, Cavalon	Aircraft serial Nos. affected: Those aircraft fitted with an oil pressure switch and warning light	
The maintenance manual to be referenced is this stated or subsequent issue.		RSUK0044 Iss 8 RSUK0061 Iss 6 RSUK0288 Iss 5
<p>This form is the response from RotorSport UK Ltd either against a problem found in the product in service requiring a containment or rectification action, or as service information for aircraft modification incorporation. For help, contact RotorSport on 44(0)1588 505060, or email compliance@rotorsport.org.</p> <p>The technical content of this document is approved under the authority of the UK CAA Design Organisation Approval Ref: DAI/9917/06</p>

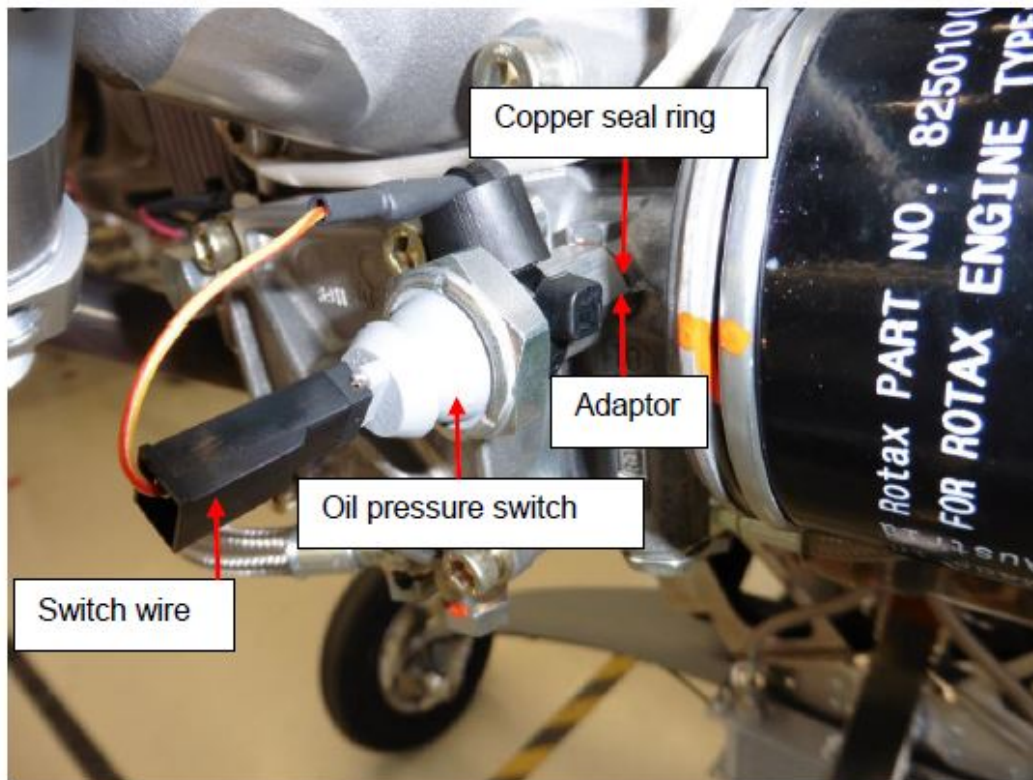
Fig.1 Oil pressure switch

For those aircraft equipped with an oil pressure warning light, a pressure switch is fitted to the oil pump casing by means of a small threaded adaptor. A case was found during initial service of an overtightened adaptor leading to breakage. This bulletin introduces a part less likely to break due to overtightening

1. For Calidus and Cavalon remove the engine cowlings as described in the aircraft's AMM
2. Remove the oil pressure switch connector (Fig 1)
3. Remove cable ties and spacer (Fig 1)

4. Unscrew the oil pressure switch complete with adaptor from the oil pump housing (Fig 1).
Caution: a small amount of oil will escape, be prepared to collect/mop-up
