RotorSport UK Ltd Service Bulletin (Permit)

Title: Cavalon fuel tank/body seal		
SB-118 Iss1	Related documents Modification: MC-357 CCAR No.: CCAR-063	Compliance Category: OPTIONAL or RECOMMENDED or MANDATORY
Applicability		
Aircraft type & model: Cavalon	Aircraft serial Nos. affected: RSUK/CVLN/001 to RSUK/CVLN/021	
The maintenance manual to be referenced is this stated or subsequent issue.		RSUK0288 Iss:6
<p>This form is the response from RotorSport UK Ltd either against a problem found in the product in service requiring a containment or rectification action, or as service information for aircraft modification incorporation. For help, contact RotorSport on 44(0)1588 505060, or email compliance@rotorsport.org.</p> <p>The technical content of this document is approved under the authority of the UK CAA Design Organisation Approval Ref: DAI/9917/06</p>

AG-SB-2016-06-B-EN – Cavalon fuel-tank inlay ring

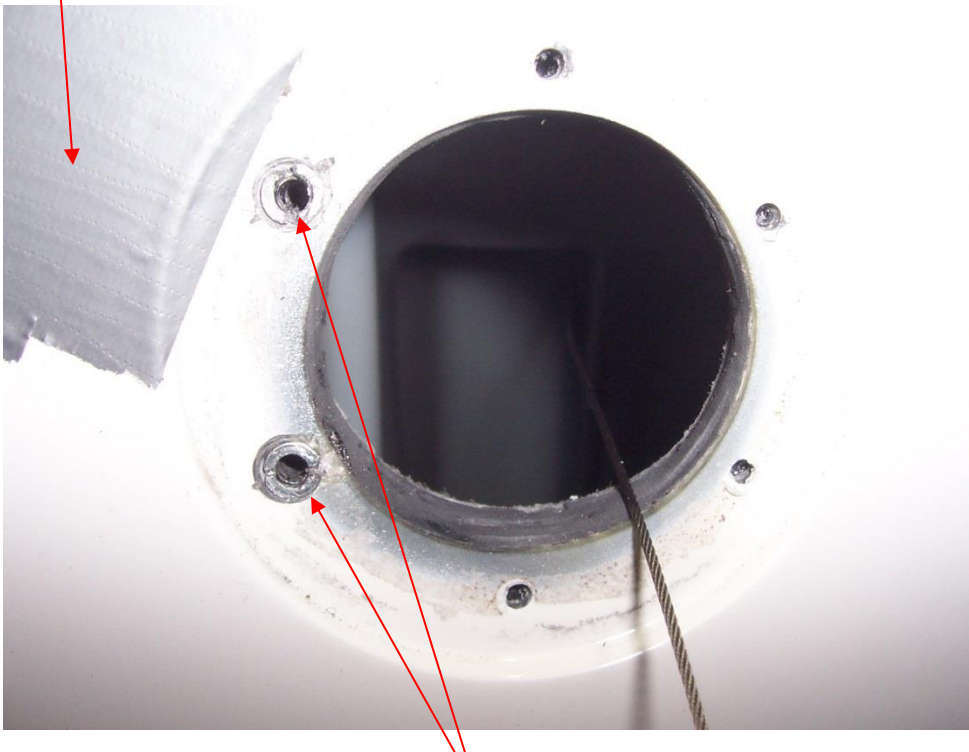
Fig. 6: Two rivnut heads slotted for drilling

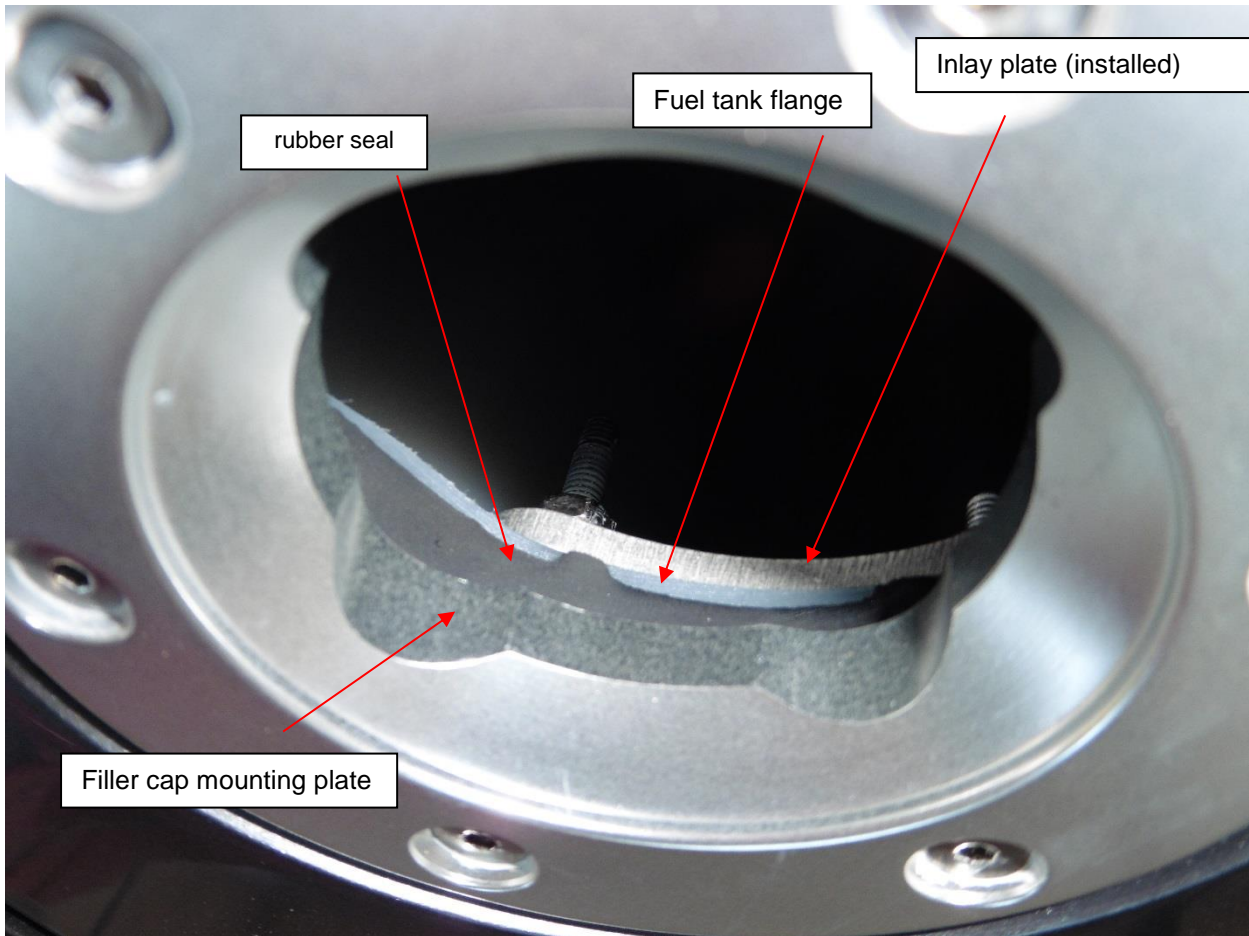
Fig. 9: fuell filler with attached inlay ring and rubber seal
