RotorSport UK Ltd Service Bulletin (Permit) Addendum

Title: Cavalon low fuel float replacement		Release date 01.Apr. 2019
SB-132 Iss1	Related documents Modification: MC-411 CCAR No.: CCAR-081	Compliance Category: OPTIONAL or RECOMMENDED or MANDATORY
Applicability		
Aircraft type & model: Cavalon	Aircraft serial Nos. affected: Any RotorSport Cavalon to serial 030	
The maintenance manual to be referenced is this stated or subsequent issue.		Cavalon RSUK0288 Iss 5
<p>This form is the response from RotorSport UK Ltd either against a problem found in the product in service requiring a containment or rectification action, or as service information for aircraft modification incorporation. For help, contact RotorSport on 44(0)1588 505060, or email compliance@rotorsport.org.</p> <p>The technical content of this document is approved under the authority of the UK CAA Design Organisation Approval Ref: DAI/9917/06</p>

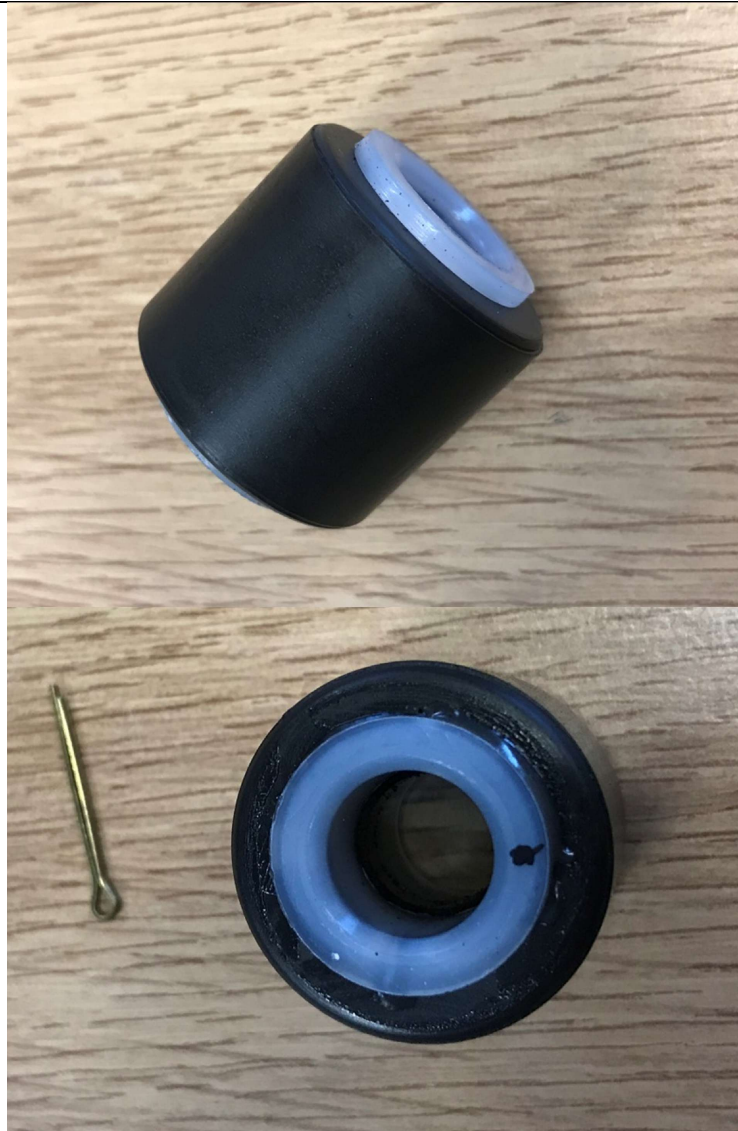
Photo showing the brass split pin and the float with the marked dot (which is fitted uppermost)

6. Remove the brass split pin from the bottom of the sensor rod. A new pin is supplied with the new float.
7. Remove the blue float and discard. Replace with the new float, with the dot uppermost.

8. Refit the split pin and fold out the pin.
9. Refit the sensor assy as a reverse of the previous instructions. Use Loctite 5331 sealant on the mating surfaces to seal the assy to the tank.

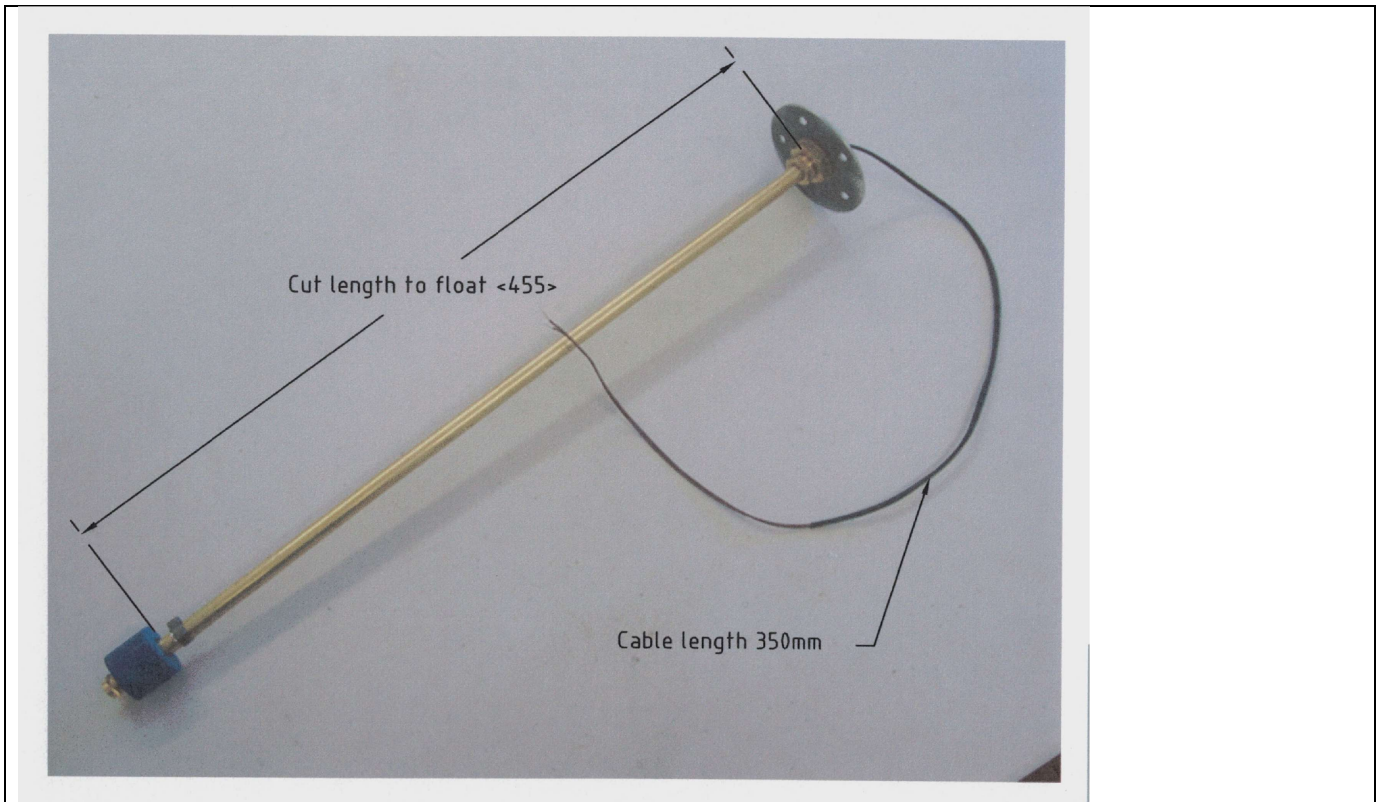
This float has been found to sometimes absorb fuel, depending on the fuel type used and altitudes operated at.

Absorption of fuel means that the float has less buoyancy, and causes a low fuel warning when in excess of the fuel low fuel warning level is in the tank.

View of the low fuel sensor assembly

This bulletin is to replace this float with a denser float material, which is less susceptible to fuel ingress and altitude changes.
