RotorSport UK Ltd Service Bulletin (Permit)

Title: Cavalon 915is Lower engine cowling heat protection		Release date 10.10.2020
SB-138 Iss1	Related documents Modification: CCAR No.: None	Compliance Category: OPTIONAL or RECOMMENDED or MANDATORY
	Applicability	
Aircraft type & model: Cavalon 915IS	Aircraft serial Nos. affected: As required, optional	
The maintenance manual to be referenced is this stated or subsequent issue.		None
<p>This form is the response from RotorSport UK Ltd either against a problem found in the product in service requiring a containment or rectification action, or as service information for aircraft modification incorporation. For help, contact RotorSport on 44(0)1588 505060, or email compliance@rotorsport.org.</p> <p>The technical content of this document is approved under the authority of the UK CAA Design Organisation Approval Ref: DAI/9917/06</p>

Title: Cavalon 915 Lower Engine Cowling Heat Protection		
AG-SB-2020-05-B-EN		Compliance Category:
Applicability		A – MANDATORY B – RECOMMENDED C – OPTIONAL
Aircraft type & model: AutoGyro Cavalon	Affected Serial number(s): All Cavalon fitted with the Rotax 915iS engine	
The maintenance manual to be referenced

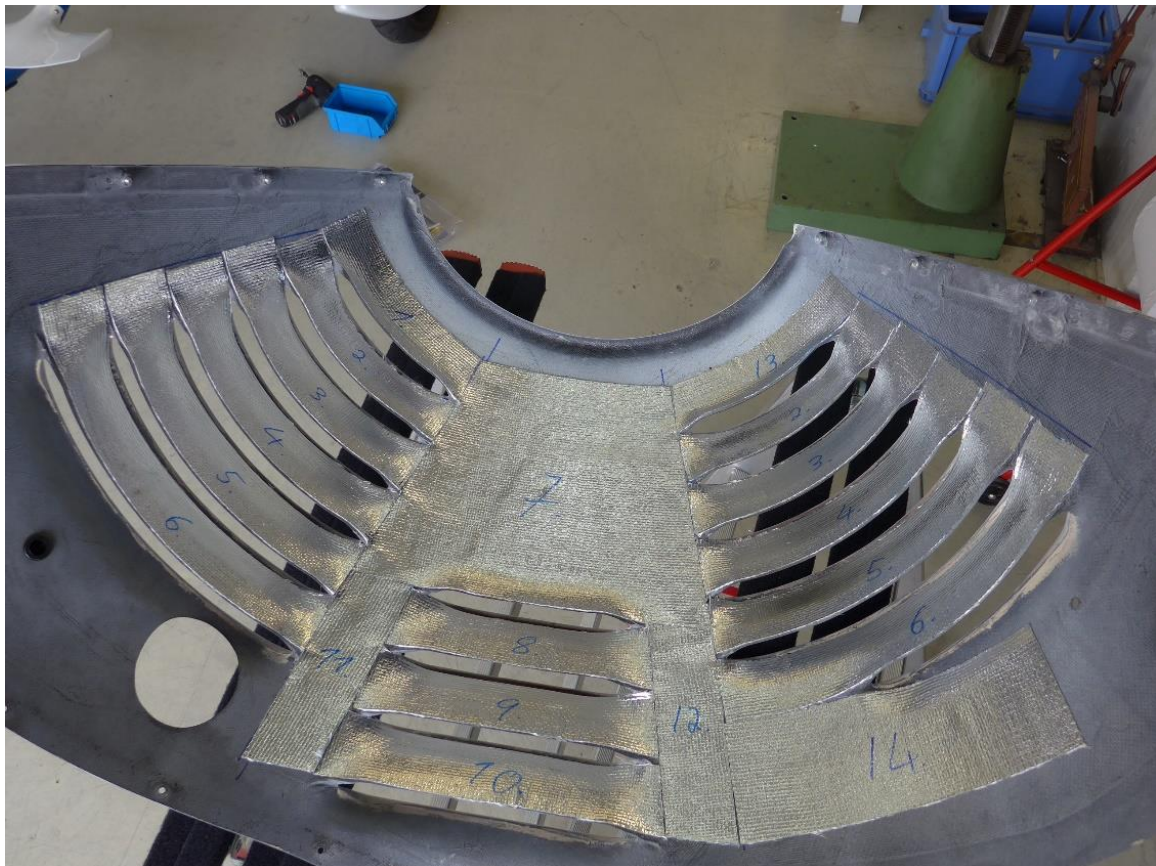
(Pic. 1)

AutoGyro has received feedback from the market that the engine exhaust manifold proximity to the lower engine cowling can cause discolouration of the cowling paint through heat radiation.

3. De-grease the inside area of the lower engine cowling in the areas where the heat protection is to be applied.
4. Attach the heat protection to the lower engine cowling using Pic. 1 below as a guide.
