Title: Cavalon window strength improvement		Release date 25.10.2022
SB-146 Iss1	Related documents Modification: MC-440 CCAR No.: None	Compliance Category: OPTIONAL-or
Applicability		RECOMMENDED or
Aircraft type & model: AutoGyro Cavalon	Aircraft serial Nos. affected: As required, optional	MANDATORY
The maintenance manual to be referenced is this stated or subsequent issue.		None

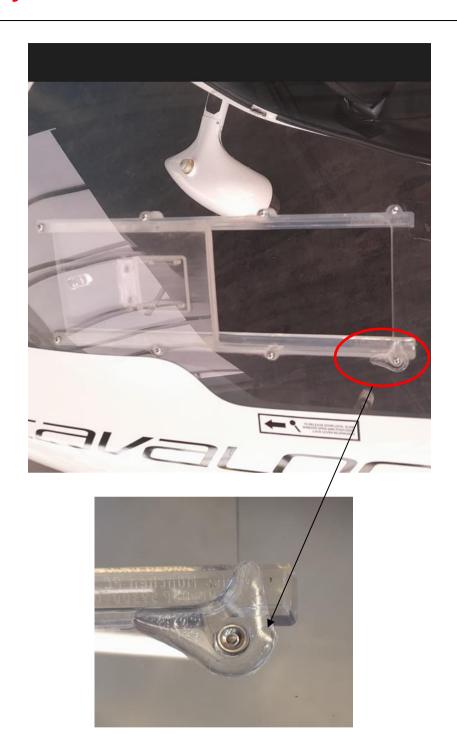
Due to improper opening and closing of the door via the ventilation window, cracks occasionally occur at the front lower corners of the ventilation windows at the screw connection.

Install reinforcement:

- Clean the surface of the reinforcement with Loctite 7063 Super Clean (PN 35915)
- ➤ Add the double-sided tape on the reinforcement
- Line up contour and hole of the reinforcement and cabin door when installing
- Put the screw back on

Tighten screws only hand-tight
