# RotorSport UK Ltd Service Bulletin (CofA)

<b>Title: Cavalon low fuel float replacement</b>		<b>Release date 01.Apr. 2019</b>
<b>SB-C-006 Iss1</b>	<b>Related documents</b> Modification: MC-411 CCAR No.: CCAR-81	<b>Compliance Category:</b>  <b>OPTIONAL</b> <del>or</del> <b>RECOMMENDED</b> or <b>MANDATORY</b>
<b>Applicability</b>		
<b>Aircraft type &amp; model:</b> Cavalon Pro	<b>Aircraft serial Nos. affected:</b> Any RotorSport Cavalon Pro to serial 005	
The maintenance manual to be referenced is this stated or subsequent issue.		RSUK0335 Iss1
<p>This form is the response from RotorSport UK Ltd either against a problem found in the product in service requiring a containment or rectification action, or as service information for aircraft modification incorporation. For help, contact RotorSport on 44(0)1588 505060, or email <a href="mailto:compliance@rotorsport.org">compliance@rotorsport.org</a>.</p> <p>The technical content of this document is approved under the authority of the UK CAA Design Organisation Approval Ref: <b>DAI/9917/06</b></p>

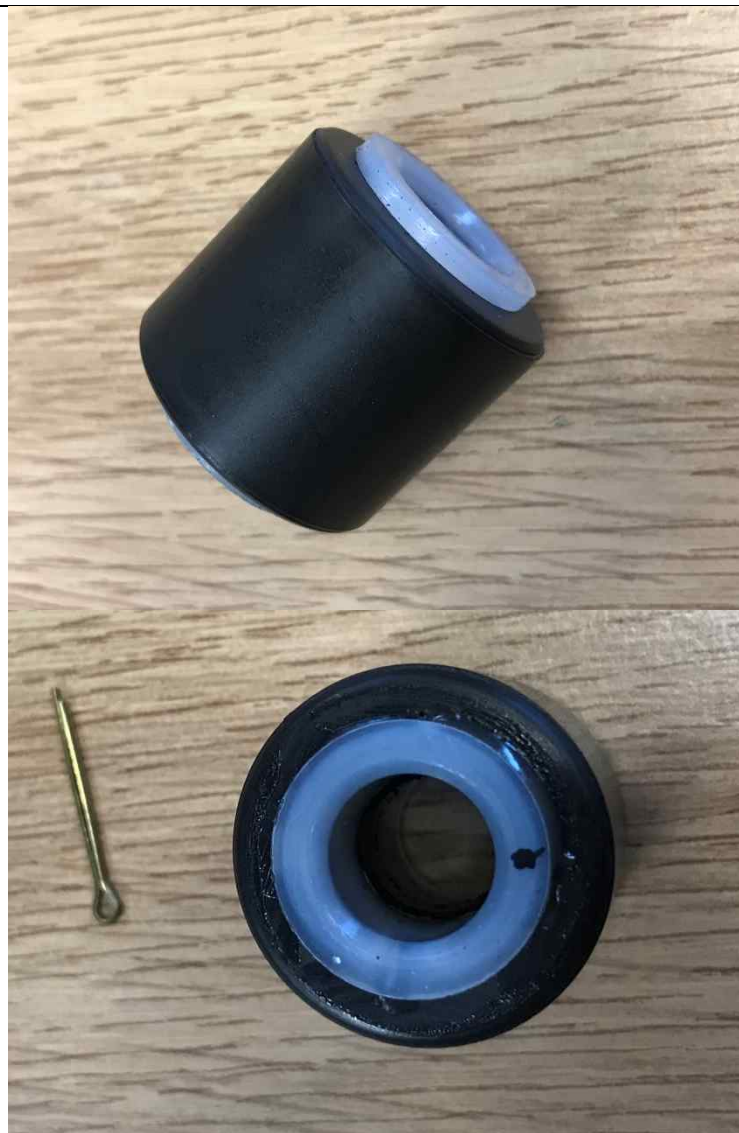
Photo showing the brass split pin and the float with the marked dot (which is fitted uppermost)

6. Remove the brass split pin from the bottom of the sensor rod. A new pin is supplied with the new float.
7. Remove the blue float and discard. Replace with the new float, with the dot uppermost.

8. Refit the split pin and fold out the pin.
9. Refit the sensor assy as a reverse of the previous instructions. Use Loctite 5331 sealant on the mating surfaces to seal the assy to the tank.

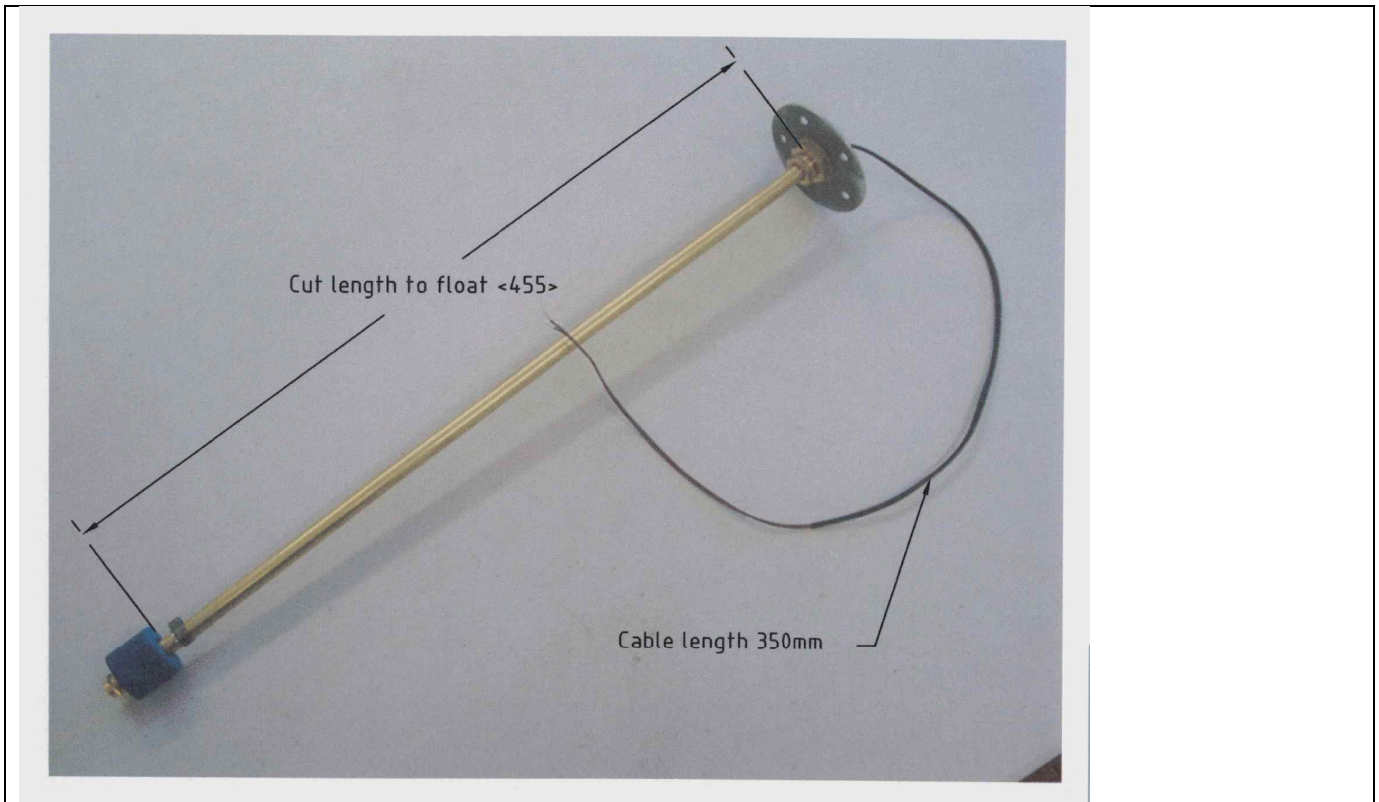
This float has been found to sometimes absorb fuel, depending on the fuel type used and altitudes operated at.

Absorption of fuel means that the float has less buoyancy, and causes a low fuel warning when in excess of the fuel low fuel warning level is in the tank.

View of the low fuel sensor assembly

This bulletin is to replace this float with a denser float material, which is less susceptible to fuel ingress and altitude changes.
