# AG-MI-2014-06-C-EN -Crimp Connection Relay Cable

MTOsport serial numbers M01173 up to and including M01217 and MTOsport, which are retrofitted with main fuse attachement kit - retrofit kit (M.EL452 / after 07.08.2014)

Within Quality checks an inaccurate crimp connection was found on the crimp connector joining the cable from the regulator relay to the fuse box

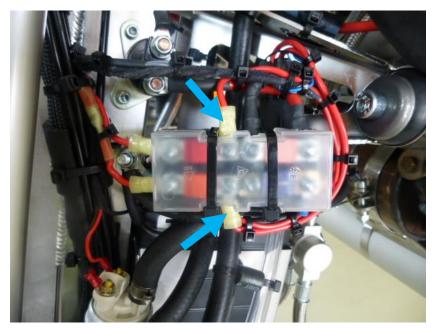
Fig. 1 - Main fuse carrier

- Main fuse carrier relay (see Fig. 1)
- Relay main fuse carrier (see Fig. 1)

- 1 Inspect crimp connection of cables marked in Fig. 1 (Accord: Fig. 2 and 3)
- 2 If crimp connection is wrong, then:
- 3 Open main fuse box by removing cable ties
- 4 Disconnect affected cable(s) from fuse and relay,release affected cable(s) by removing cable ties, replace affected cable(s) by new part(s)
- 5 Assembly in reverse order

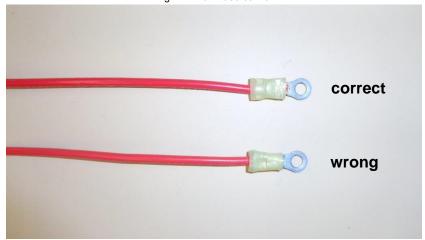
Fig. 2 – Crimp connection correct/wrong (outside)

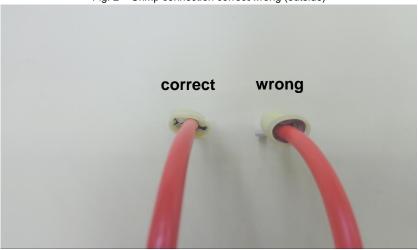
Fig. 3 – Crimp connection correct/wrong (inside)
