Title: IVO Motor Replacement Part		
AG-SB-2021-08-B-EN	Effective Date: 06 Sep 2021	Compliance Category: A – MANDATORY B – RECOMMENDED C – OPTIONAL
Applicability		
Aircraft type & model: All AutoGyro models	Affected Serial number(s): All AutoGyro models fitted with an IVO propeller	
The maintenance manual to be referenced is this stated or subsequent issue.		As per AutoGyro website
This form is the response from AutoGyro GmbH either against a problem found in the product in service requiring a containment or rectification action, or as service information for aircraft modification incorporation. For help, contact airworthiness@auto-gyro.com .

Reason and overview of the Service Bulletin (cause of problem if known)

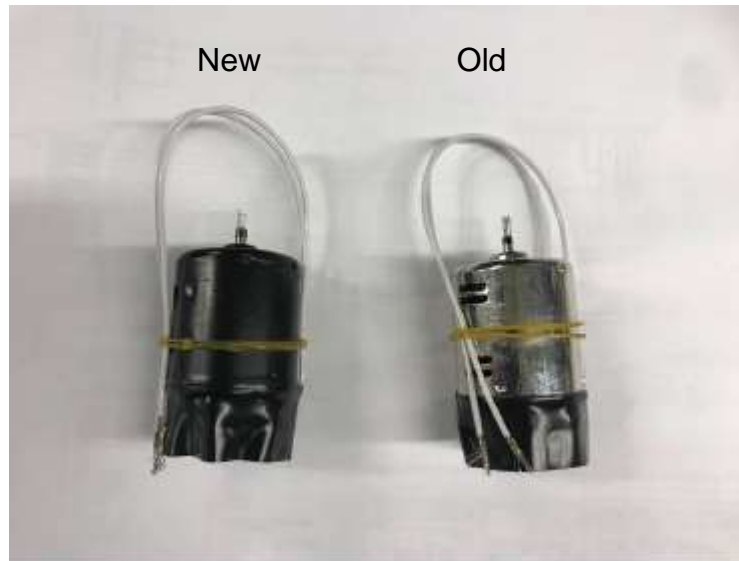
Pic. 1

The IVO propeller pitch adjustment motor reliability does not meet AutoGyro and market expectations, despite the many improvements implemented.
The propeller manufacturer, IVO corp, have now incorporated a different electric motor. The new motor has been tested by AutoGyro and a modified version accepted for market release.
This version incorporates capacitors to reduce electrical interference noise and subsequent effect on the aircraft radio reception.
Functional testing demonstrates that this motor offers a substantial improvement in reliability.

1. Remove the propeller spinner if fitted.
2. Replace the IVO propeller motor (Pic. 1) with the new version (48213) in accordance with 'RSUK0325 Issue 2 RotorSport IVO-prop Manual' available in the maintenance section of the AutoGyro home page.
