RotorSport UK Ltd

Service Bulletin

SB No.: 024 issue 2	CCAR No.: None	Classification:
Aircraft type & model (applicability) RotorSport UK MT-03 and MTOsport	Aircraft serial Nos. effected RSUK/MT-03/all RSUK/MTOsport/all	OPTIONAL or RECOMMENDED or MANDATORY

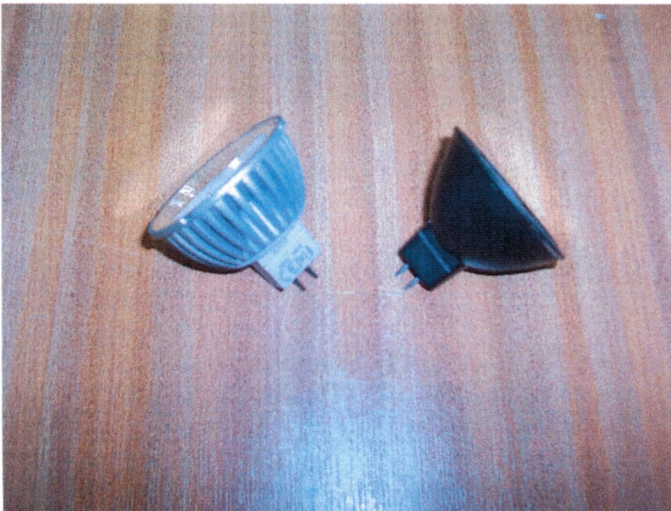
Problem description & cause of problem if known
 The standard halogen lamp (RSD4163) fitted to the landing lights of MT-series aircraft has a relatively high power consumption (12V 50W each) and if used continuously can become hot. An optional LED lamp is now available (RSD4617) that consumes considerably less power (12V 4W each) and runs cooler.

RSD4617 LED (left) and RSD4163 halogen (right)

Parts required to implement this bulletin
 2-off LED lamp RSD4617. (Note that this supercedes RSD4511 previously approved for fitment under MC-139)

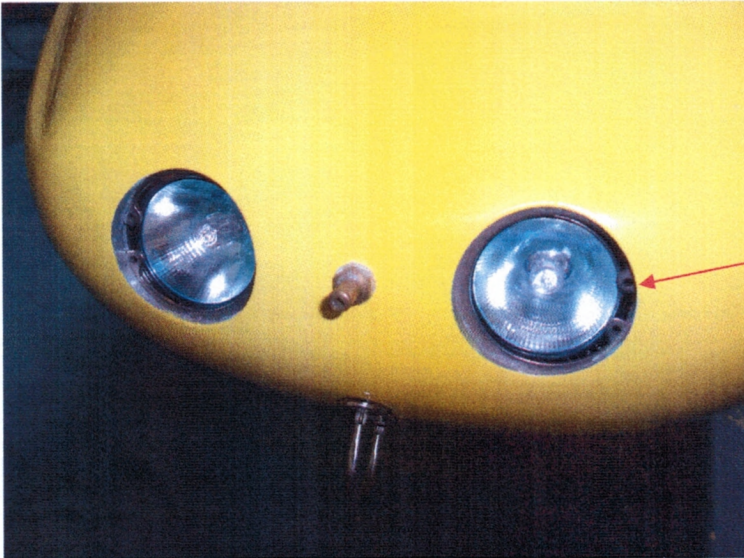
Earlier method of lamp retention

1. If a luggage locker is fitted then remove the hatch cover. If a landing light shield is in place then remove (SB-023 refers).
2. On aircraft manufactured prior to 2010 each lamp is retained by a circlip accessible outside the nose – remove the circlip then the lamp. On later aircraft each lamp is retained by a tension spring accessible through the hatch – pull one end of the spring until its hook can be removed from the surround then remove the lamp. NB: On very early MT-03 aircraft the lamps are bonded into the nose moulding by a bead of Sikaflex EBT mastic. This must be cut-away using a sharp knife, the lamp replaced and the Sikaflex reinstated. Access is gained by reaching under the instrument panel and fwd of the rudder pedals

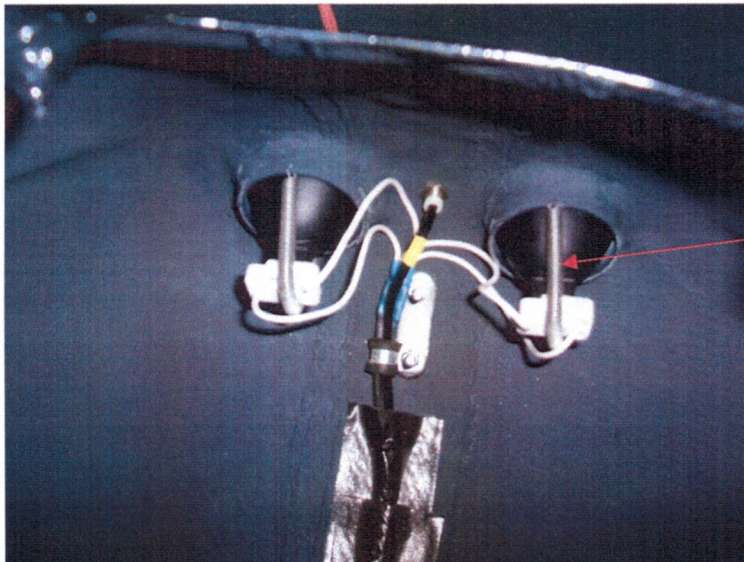
Later method of lamp retention
