# RotorSport UK Ltd

## Service Bulletin

<b>SB No.: 028 issue 1</b>	CCAR No.: None	Classification: <del>OPTIONAL</del> or <del>RECOMMENDED</del> or <b>MANDATORY</b>
Aircraft type & model (applicability) RotorSport UK MTOsport series	Aircraft serial Nos. effected RSUK/MTOsport serial 24 to 036

### Problem description & cause of problem if known

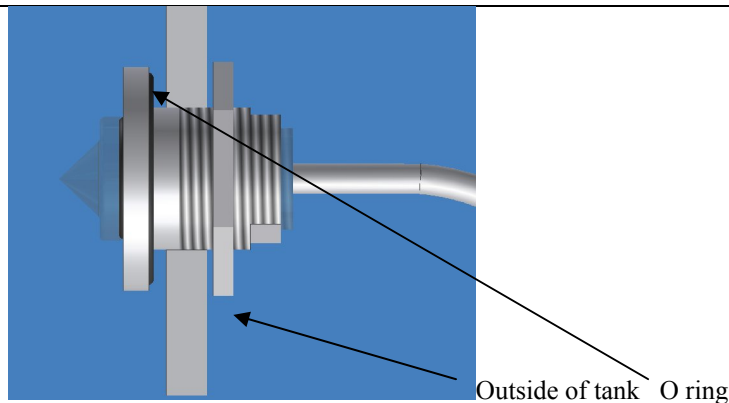
Computer view of sensor loosely fitted to the fuel tank, tank wall sectioned for clarity.

5. Using a bent wire, pull the sensor assy through the tank and through the hole, ensuring the O ring is fitted to the groove in the metal sleeve. Apply Loctite 243 to the threads, fit nut, and tighten securely. An 11mm AF spanner will fit over the end of the sensor housing to aid tightening. No sealant is needed.
