RotorSport UK Ltd

Service Bulletin

SB No.: 034 issue 3	CCAR No.: None	Classification: OPTIONAL or RECOMMENDED or MANDATORY
Aircraft type & model (applicability) RotorSport UK MT-03and MTOsport series	Aircraft serial Nos. effected RSUK/MT-03/all RSUK/MTOsport all

Effective date: 08.10.10

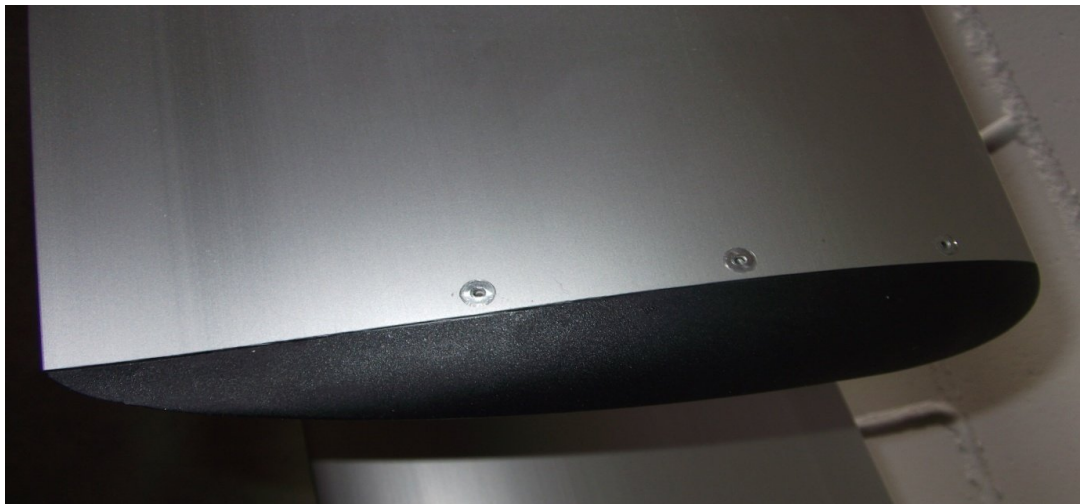
5. Using the x5 magnifier, carefully visually inspect the area of the outboard bolt hole on both the underside and top-side of the rotor-blade. On Aircopter blades (these have a flat outer end cap) any crack is likely to be around 10mm outboard of the hole, or at the hole. On AutoGyro blades (rounded outer end cap) any crack is likely to be across the outboard bolt hole itself. Obviously, no cracks whatsoever are permitted in any area of the blade.

AutoGyro end cap for reference

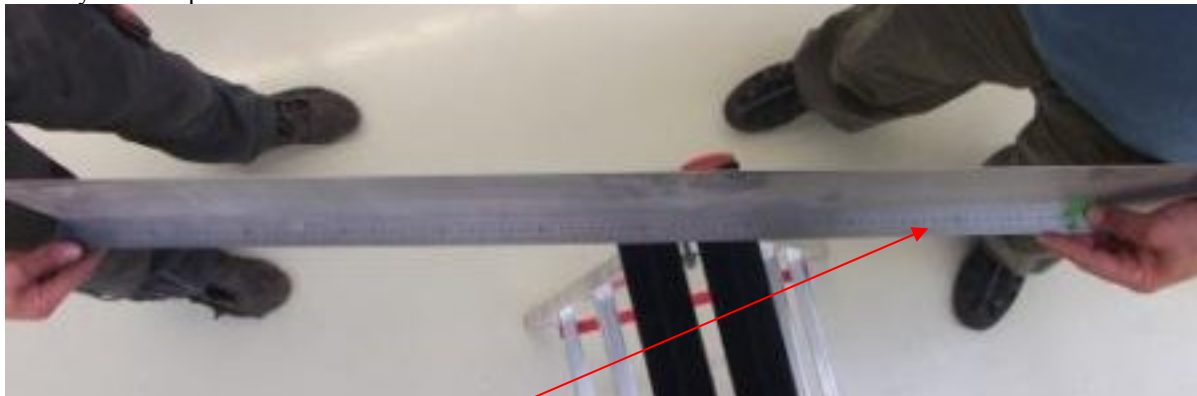
4. Raise each blade on one edge, and lay the straight edge along the centreline of the bolt holes (see photo). Check for bend around the outboard hole. No bend permitted.

Holding a straight edge to the blade

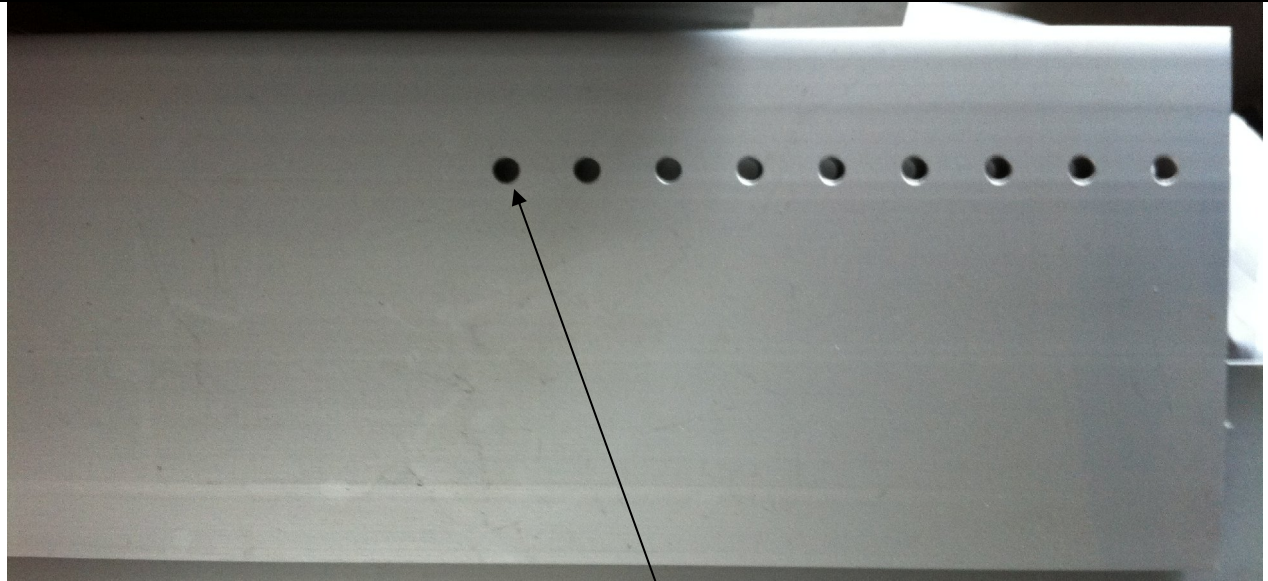
View of blade underside Outboard bolt hole.

- Note the inspection in the aircraft logbook, and sign with engineer authorisation number.
- NOTE! The CAA require that the actual inspection is carried out and signed off by an A3-7 authorised person only!
- If the rotor is considered defective it is to be replaced. Contact RotorSport UK Ltd immediately.
- Advise RotorSport UK Ltd of the inspection completed – registration, serial no of aircraft and of the rotor, aircraft hours logged, date of inspection. A log is kept of aircraft checked.
