RotorSport UK Ltd

Service Bulletin

SB No.: SB-053 Iss1	CCAR No.:	Classification:
Aircraft type & model (applicability) MT-03 MTOsport Calidus	Aircraft serial Nos. affected See comments below and refer to Appendix 1 for list of aircraft serial numbers affected.	OPTIONAL or RECOMMENDED or MANDATORY

MANDATORY!

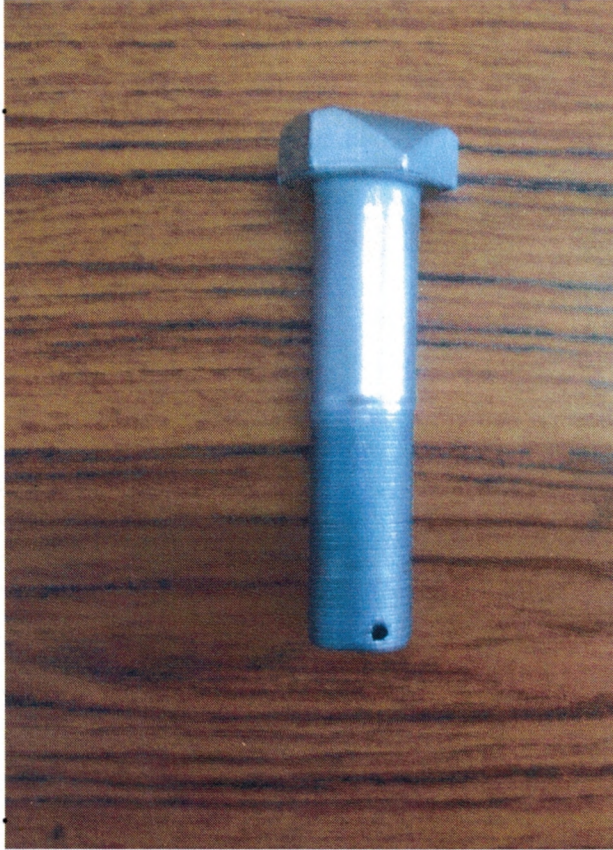
RSUK have been made aware of a possible deficiency in the manufacturing process of main-bearing bolts part number BT696 (original rotor system) . For avoidance of doubt any bolt believed to be affected is to be changed. This will require a simple external visual examination, and if the potential deficiency is confirmed, then replacement is required.

1.1. Before removing any part, check whether the main bearing bolt is black (unplated) or silver coloured (zinc plated). ONLY zinc plated bolts installed prior to the effective date need to be changed

BT696 single split-pin hole (zinc plated)

Remove and discard bolt BT696 and replace with RSD6361, using a smear of light oil on the bolt shank and exposed surfaces only. Use "3-in-1" oil RSD4531 or equivalent, do not lubricate the thread.

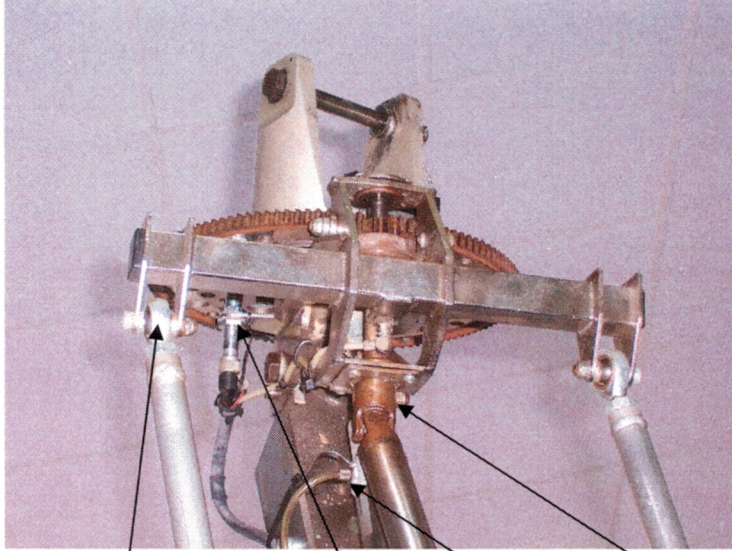
control rod mounting speed sensor 4mm air pipe UJ cross-bolt

MT-03 installation ready for removal

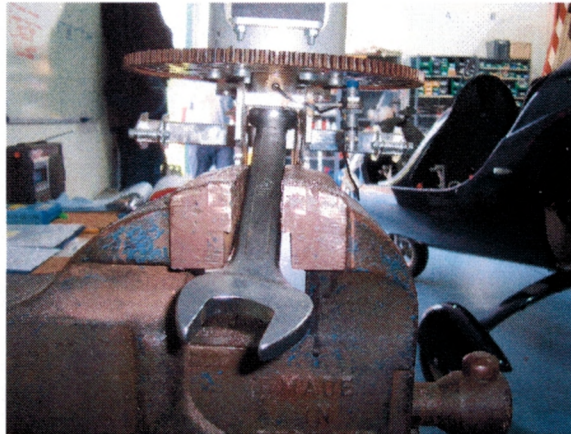
Head assembly held in bench-vice

1. Place a 30mmAF ring spanner on the hex-head bolt on the underside of the rotor-head. Clamp this ring spanner in a substantial vice. Note the orientation of the bolt head.

1. Place a 30mmAF ring spanner on the hex-head bolt on the underside of the rotor-head. Clamp this ring spanner in a substantial vice as shown in the photo above. Note the orientation of the bolt head.

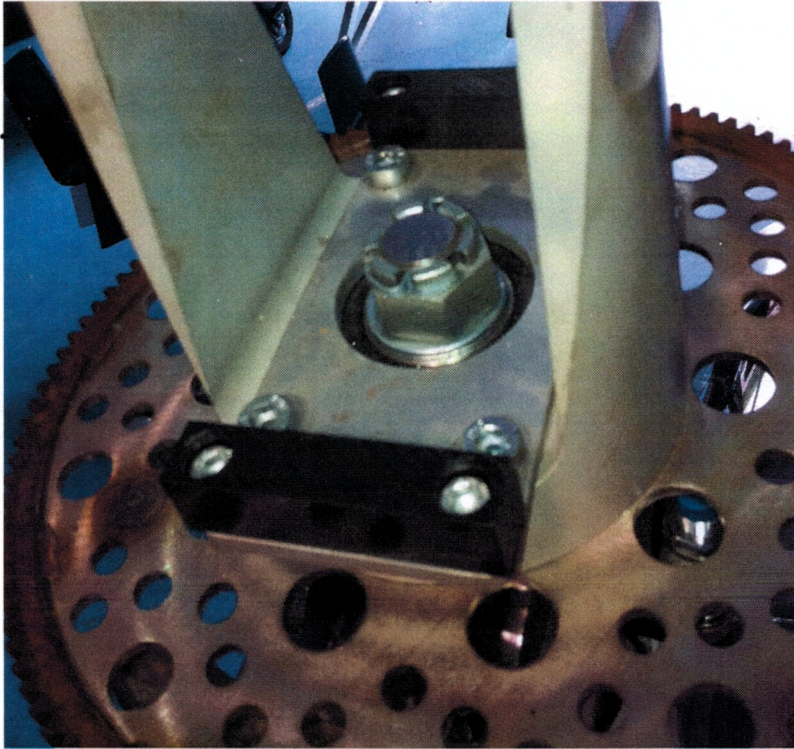
Top view of rotor bearing nut with split pin fitted
– original rotor system.

6. Form the new split-pin supplied in the kit. Back-off to nearest split-pin hole is acceptable but minimum torque 140Nm must be realised. Form pin in nut only as shown in later bulletin photo.
