# RotorSport UK Ltd

## Service Bulletin

<b>SB No.: 055 Issue 1</b>	CCAR No.: CCAR-005	Classification: <b>OPTIONAL or RECOMMENDED or MANDATORY</b>
Aircraft type & model (applicability) RSUK/MT03 and RSUK/MTOS	Aircraft serial Nos. effected RSUK/MT03/all RSUK/MTOS/all

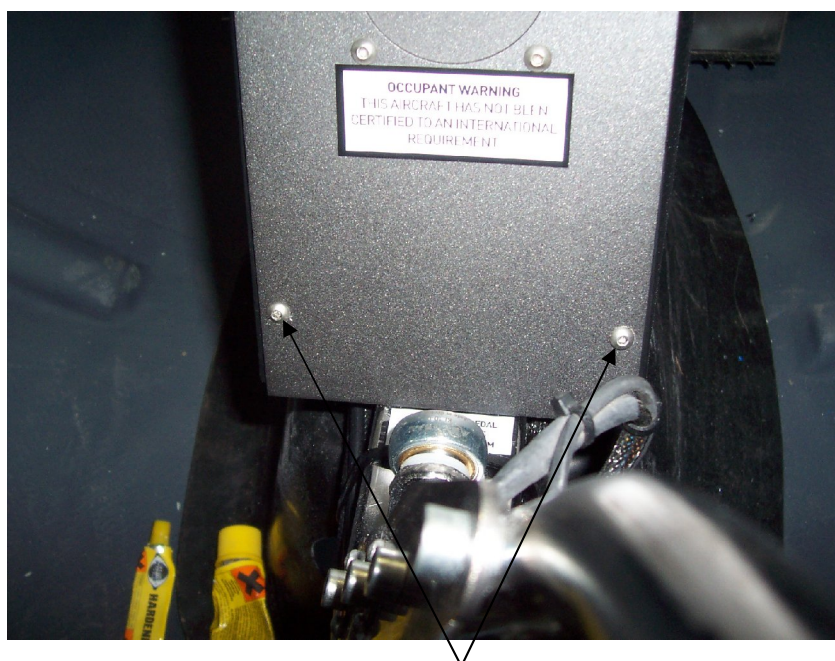
Instrument panel lower mounting screws

During a number of permit renewals CAA surveyors have reported that the lower two instrument panel-mounting screws have been found loose. This is believed to be a result of relative flexing of the airframe and enclosure combined with vibration from the engine and rotor. These mounting screws are fitted into “Riv-Nut” threaded bushes and conventional Loctite cannot be used, as during removal the riveted fastening could fail before the thread releases. However, use of a low-shear-strength grade of Loctite allows adhesive locking to be used – Loctite 222 (coloured violet) has typical breakaway torque 6Nm, whereas Loctite 243 (coloured blue) has 20Nm.

- 1) Remove and replace each of the two lower M4 fasteners in turn, placing a small amount of Loctite 222 Threadlocker on the male thread before replacement.
- 2) It may be necessary to apply a relative load between the enclosure (with the knee) and the instrument panel (with the hand) to align the threads whilst replacing the screws.
- 3) Clean any surplus adhesive from the panel using a soft cloth
