RotorSport UK Ltd Service Bulletin

Title: Pre-rotator bendix shaft retention		
SB No.: 086 Iss1	Related documents MC No: None CCAR No.: 060	Compliance Category: OPTIONAL or RECOMMENDED or MANDATORY
Applicability		
Aircraft type & model: MTOsport, Calidus, Cavalon MT-03	Aircraft serial Nos. affected: Any a/c manufactured before 7/14 If a replacement bendix shaft has been fitted since original build.

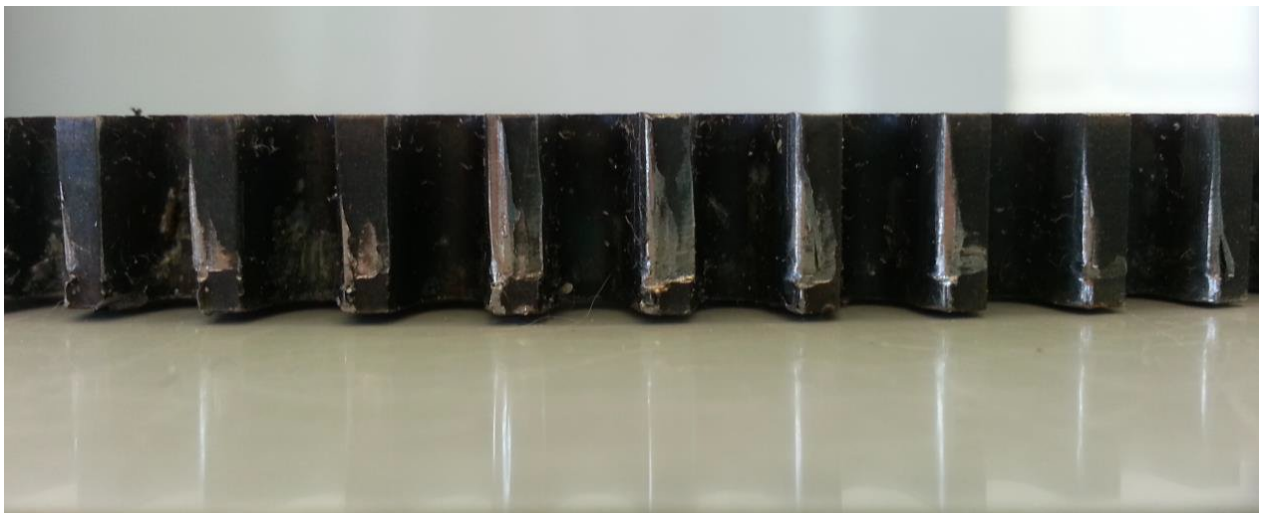
- 1 Inspect the wear pattern and gear mesh of pre-rotator upper engagement.
- 2 If the wear pattern is uneven (see Fig. 1) the condition of the bendix shaft must be inspected, otherwise this is optional. Remove the lower bearing (see relevant AMM) and ensure that the shaft is, in the free load condition, centrally positioned in the bearing seating. If free play in the upper bearing is present, the following must be carried out:

Fig. 1 - Wear Pattern (uneven)

- 3 **Free play due to bearing abrasion:** Replace upper bearing (see relevant AMM) and on re-assembly retain the bendix shaft with Loctite 638 into the upper bearing. Reassemble lower bearing.

- 4 **Free play due to abrasion of the bendix shaft by the ball bearing inner ring:** On re-assembly retain the bendix shaft with Loctite 638 into upper bearing. Reassemble lower bearing.
If free play is greater than 1/10 mm, then replace the bendix shaft with a new part and retain in the upper bearing with Loctite 638.
