RotorSport UK Ltd Service Bulletin (Permit)

Title: Funke radio adaptor		
SB-119 Iss1	Related documents Modification: MC-359 CCAR No.: None	Compliance Category: OPTIONAL or RECOMMENDED or MANDATORY
Applicability		
Aircraft type & model: MT-03 MTOsport Calidus Cavalon	Aircraft serial Nos. affected: RSUK/MT03/ RSUK/MTOS/ RSUK/CALS/ RSUK/CVLN/ any requiring upgrade of radio to 8.33 kHz channel spacing	
The maintenance manual to be referenced is this stated or subsequent issue.		RSUK0012 Iss9 RSUK0044 Iss8 RSUK0061 Iss7 RSUK0288 Iss5
<p>This form is the response from RotorSport UK Ltd either against a problem found in the product in service requiring a containment or rectification action, or as service information for aircraft modification incorporation. For help, contact RotorSport on 44(0)1588 505060, or email compliance@rotorsport.org.</p> <p>The technical content of this document is approved under the authority of the UK CAA Design Organisation Approval Ref: DAI/9917/06</p>

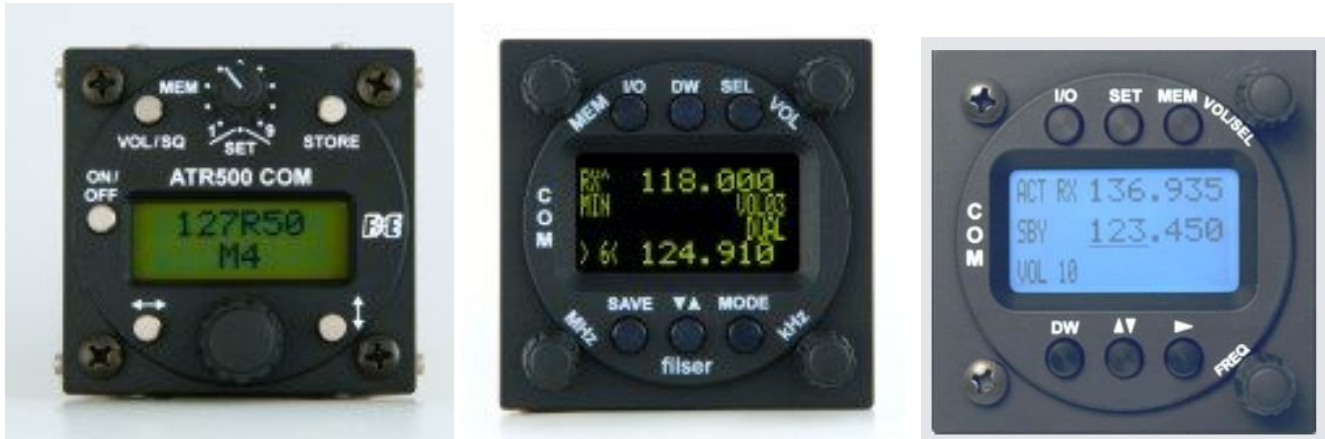
1. It may be possible to complete the installation with the instrument panel in place, but this is dependent on cable/pipework freedom for access. If the instrument panel is removed, then when replaced the pitot-static system must be checked as described in the aircraft AMM.
2. The ATR833 is essentially the same frame-size as the ATR500 but has two rotary knobs coaxial with the two right-hand mounting screws. It also has a 25-way D-type connector instead of the 15-way D-type connector.

The centre picture shows the early ATR833 with four rotary knobs (Part No 833-(1xx)-(1xx). As of June 2011 there are two knobs only, at RHS (Part No 833-(2xx)-(2xx).

3. Remove the ATR500 (if fitted)
Drill through the two right-hand mounting holes 6.5mm dia, removing the swarf with a Hoover or similar. Deburr. Leave the two left-hand mounting holes 4.6mm dia. Fit the radio to the panel using a minimum amount of Loctite243 on the fittings
