RotorSport UK Ltd Service Bulletin (Permit)

Title: MTOsport 2017 mast drain hole		Release date 17.06.2019
SB-133 Iss1	Related documents Modification: CCAR No.: None	Compliance Category: OPTIONAL or RECOMMENDED or MANDATORY
Applicability		
Aircraft type & model: MTOsport 2017	Aircraft serial Nos. affected: Serial 001 to 011	
The maintenance manual to be referenced is this stated or subsequent issue.		RSUK0395 Iss 1
<p>This form is the response from RotorSport UK Ltd either against a problem found in the product in service requiring a containment or rectification action, or as service information for aircraft modification incorporation. For help, contact RotorSport on 44(0)1588 505060, or email compliance@rotorsport.org.</p> <p>The technical content of this document is approved under the authority of the UK CAA Design Organisation Approval Ref: DAI/9917/06</p>

Title: Check For Presence Of Mast Root Drain Hole		
AG-SB-2019-01-A-EN		Compliance Category:
Applicability		A - MANDATORY B - RECOMMENDED C - OPTIONAL
Aircraft type & model: MTO2017	Affected Serial number(s): All MTO2017 models	
The maintenance manual to be referenced is this stated or subsequent issue.		As per AutoGyro websi

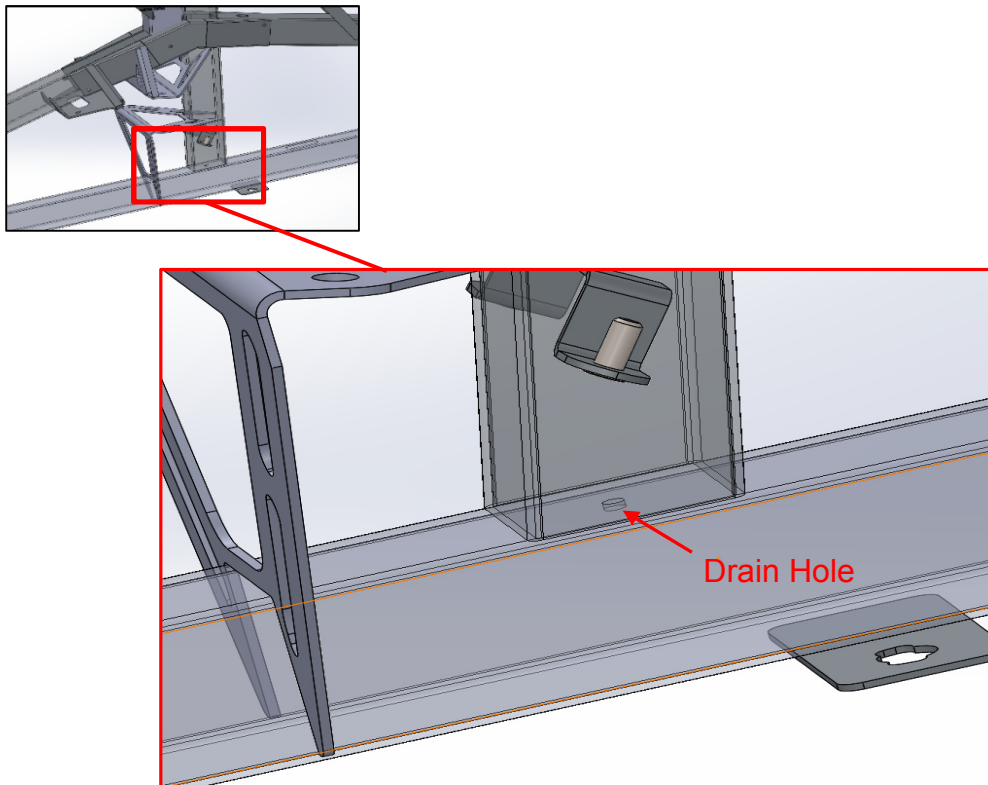
Fig. 1

It has been found that during production of the main frame, the main mast root drain hole (fig 1) may have been left out of the frame assembly on a small number of MTO2017 frames currently in the market.

This may lead to flushing fluids used during the electrochemical polishing process remaining trapped in the forward mast tube.
