Service Information Letter

RotorSport UK Ltd Poplar Farm, Prolley Moor, Wentnor, Bishops Castle, Shropshire,UK, SY9 5EJ	
SILNo.: 003 issue 1, dated 12.02.2010	CCAR No.: None
Aircraft type & model (applicability) RotorSport MTOsport	Aircraft serial Nos. effected MTOsport/015 onwards Rotax 912ULS engines S/no 6.775.360 onwards
The purpose of this document is to communicate information to pilot owners of RotorSport aircraft that may be of benefit. If there is any clarification required of the content of the letter, contact RSUK on 44(0)1588 650769, or email info@rotorsport.org .	
<u>Subject</u> "Soft-start" ignition control module for Rotax 912 ULS engines	Issue date: 12.02.2010
<u>Safety effect</u> Improved engine operation, particularly in cold conditions	
<u>Weight and CG effect</u> None	
<u>Background</u> In late 2009 BRP-Powertrain, the manufacturer of Rotax engines, introduced onto production engines revised ignition control modules (2 per aircraft) that maintain the period of the retarded ignition setting used for engine start. This reduces vibration loads on the slipper and sprag-clutch, and engine mountings, particularly in cold-start situations.. A result of this is that at

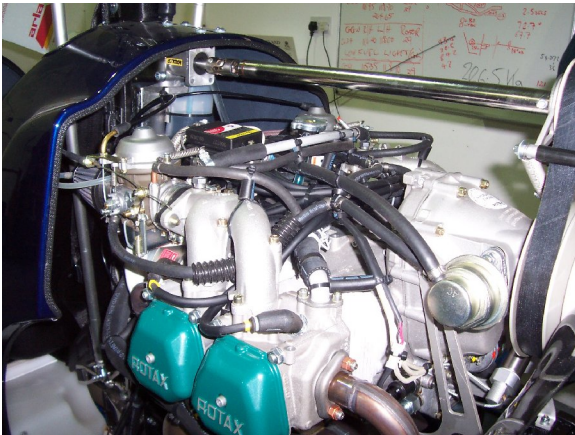
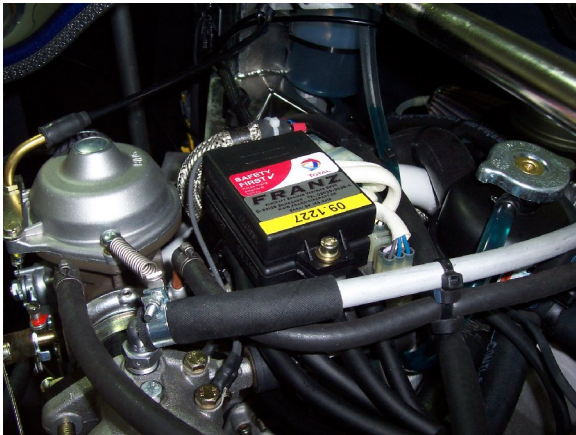
<u>Implementation and identification</u> The revised modules have been fitted to 912ULS engines S/No 6.775.360 onwards. They are located together on top of the engine and may be identified by a yellow stripe across the body of the ignition control module (see photo below). In operation, instead of the timing advancing between 650-1000rpm it will now advance at approximately 2,500rpm. Also, there will be a delay of about 3-8 secs from the time the ignition switches are turned off until the time the ignition timing retards.	
<u>Recommendation</u> Owners should familiarise themselves with the changed engine characteristics by observation during ground running in cold conditions, and by reference to the Rotax engine manual.	
References:
