# RotorSport UK Ltd

## Service Information Letter

**SIL-013**

## Subject: 2-year replacement of low-fuel-level sensor

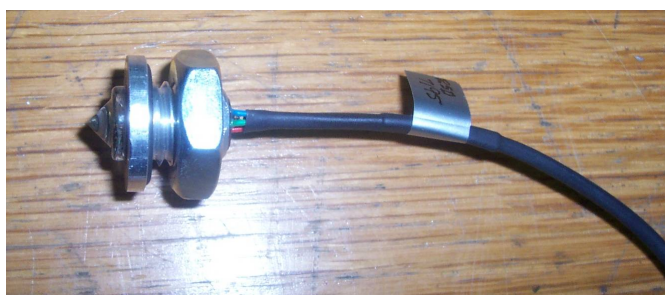
Honeywell sensor (plastic body)

Optomax sensor assembly (aluminium housing)

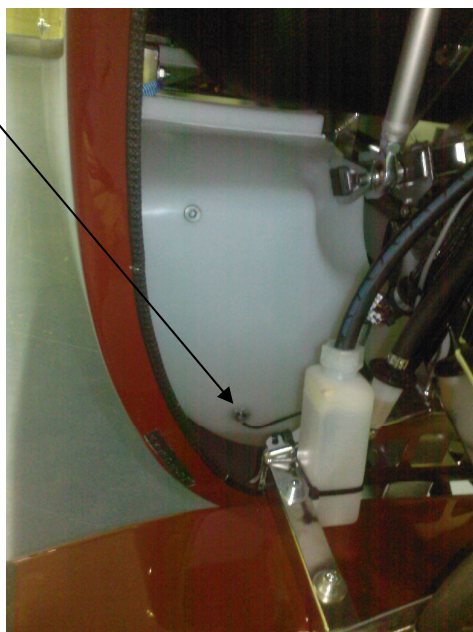
The fuel sensor of MT-series aircraft is readily accessible from the rear of the aircraft - see AMM's RSUK0012 (MT-03) and RSUK0044 (MTOsport)

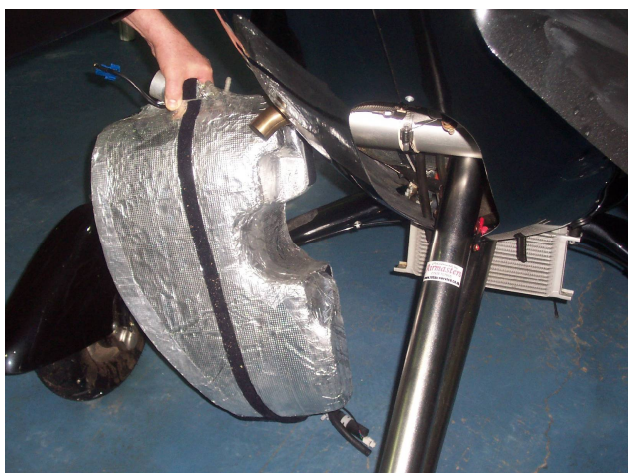
To access the fuel sensor in Calidus aircraft it is necessary to drain all fuel and remove the left-hand fuel tank (see AMM RSUK0061). Only Optomax sensors will be found in Calidus aircraft.

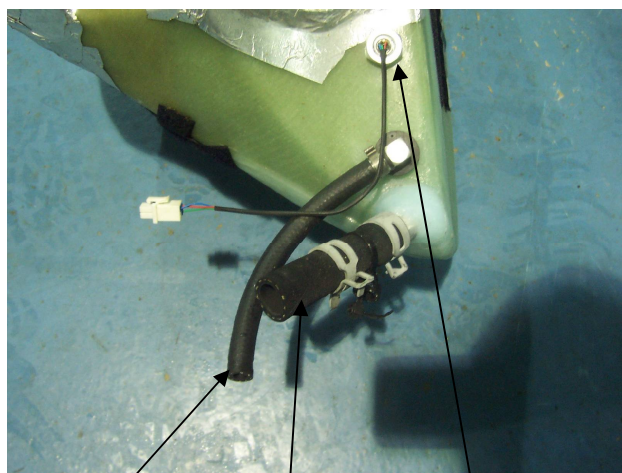
Tank removed from LHS of aircraft

Delivery hose    Transfer hose    Sensor

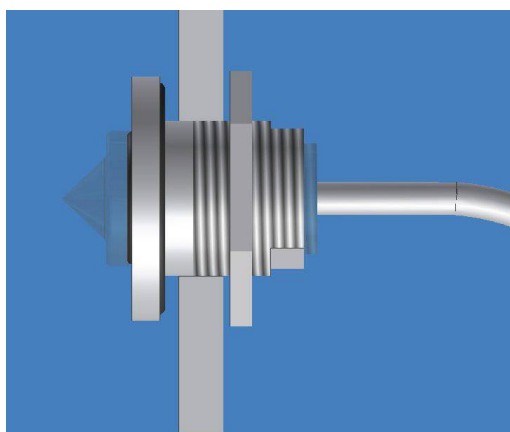
Installation arrangement for Optomax sensor assembly  
(sensor, aluminium housing, O-rings and back-nut)

The low-fuel sensor RSD4555 or RSD4335 should be replaced every two years (alternatively function checked every six months). Replacement sensors are supplied with metal housing, O-ring and back-nut as Installation kit RSD7195.
