RotorSport UK Ltd

Service Information Letter

SIL- 021

Subject: Software Upgrade for Digital ASI and Altimeter

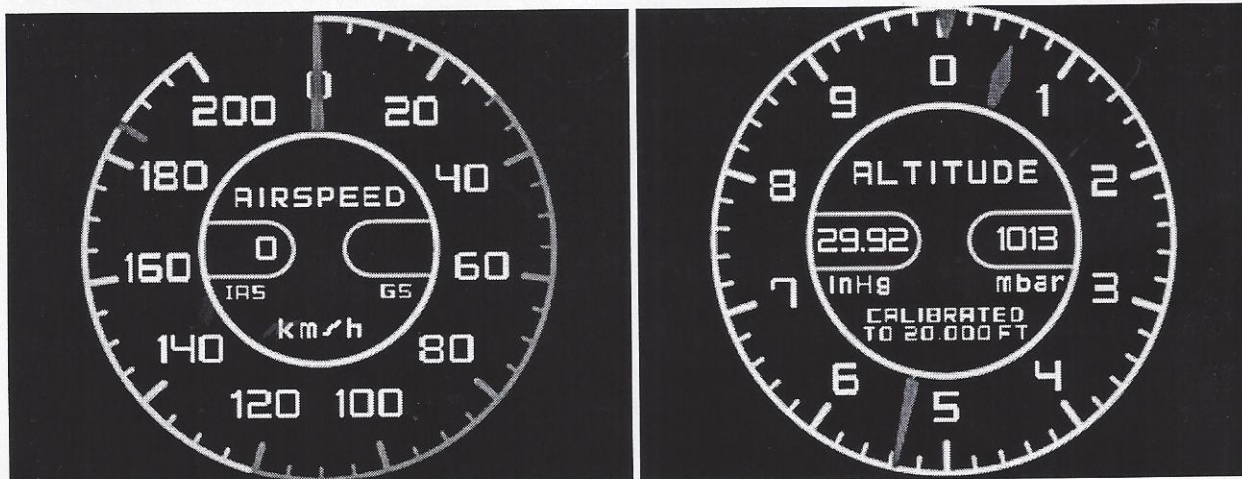
Original instrument display

AutoGyro has listened to market feedback regarding the visual appearance of instrument displays, and of the device reliability. The company decided to offer an upgrade to owners that makes the devices easier to read in different lighting conditions, and improves the operational reliability. Any device with a display as shown below may be upgraded to software level 2.17.
