RotorSport UK Ltd

Service Information Letter

SIL- 022	Issue: 1	Dated: 05.06.18	CCAR no: None
-----------------	-----------------	------------------------	----------------------

Subject: Coolant level indicator interpretation

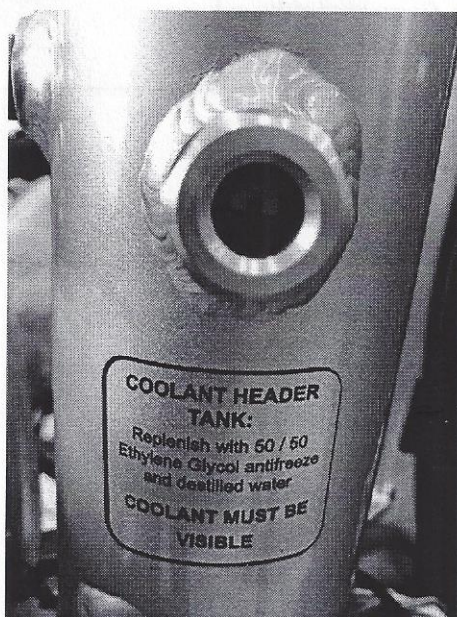
The integral viewing window built into the coolant header tank is designed to permit the inspecting person to determine that adequate coolant is present in the coolant tank before aircraft operation. During aircraft assembly it was found that sometimes the coolant hangs in a meniscus in the viewing window. This may lead the inspector to believe that adequate coolant is present, when the actual coolant level is low.

Photo of viewing window, with meniscus of coolant showing.

The only acceptable indication for safe flight is when the window is bluish in colour, indicating that the coolant level is above the viewing window.

If the window is clear, or there is a meniscus of coolant showing in the window as in the photo, then the coolant level is considered low and must be topped up.
