# RotorSport UK Ltd

## Service Information Letter

**SIL-026**

**Subject: Effective airframe inspection**

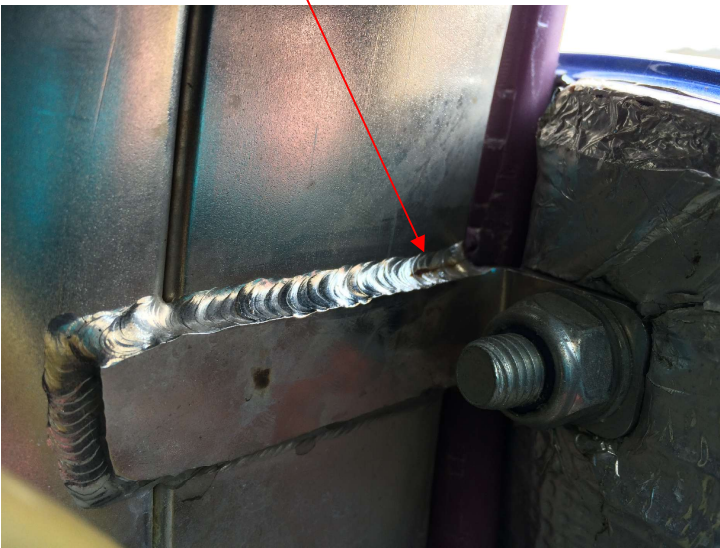
These aircraft have now accumulated many years and hours in service, resulting in service issue reports submitted to RSUK. Within these RSUK has been advised of cracks in the suspension bow mounting bracket attachment to the mast tubes, and in the front edge of the folded bracket itself. Cracks have also been found in the upper body mounting bracket weld.

Crack in right-hand upper body bracket weld

The issues are not safety critical, and are resolved by the application of the appropriate Service Repair SAR-020 (body bracket), 023 and 024. They are also long term fatigue based, dependent on operational usage, and controlled by the 100hr service inspection interval.

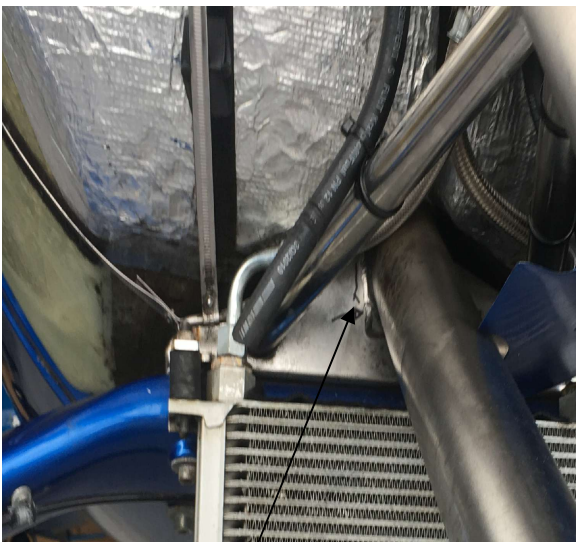
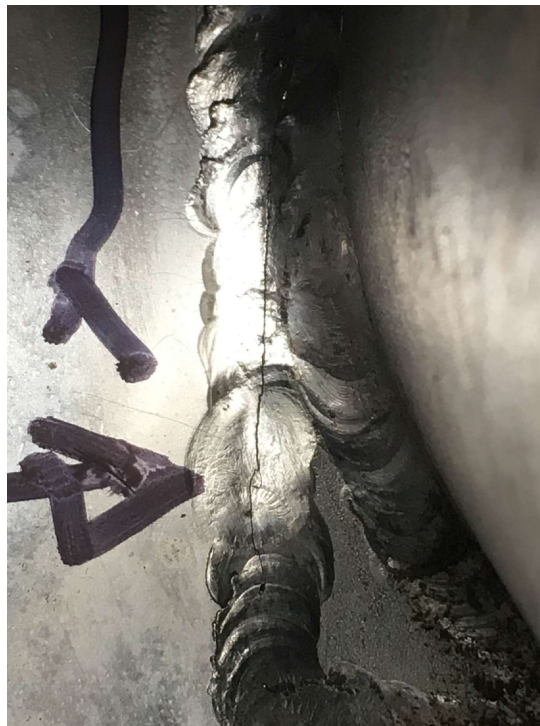
Crack position (could be either side of the mast) between the rear bracket and the mast/keel tube

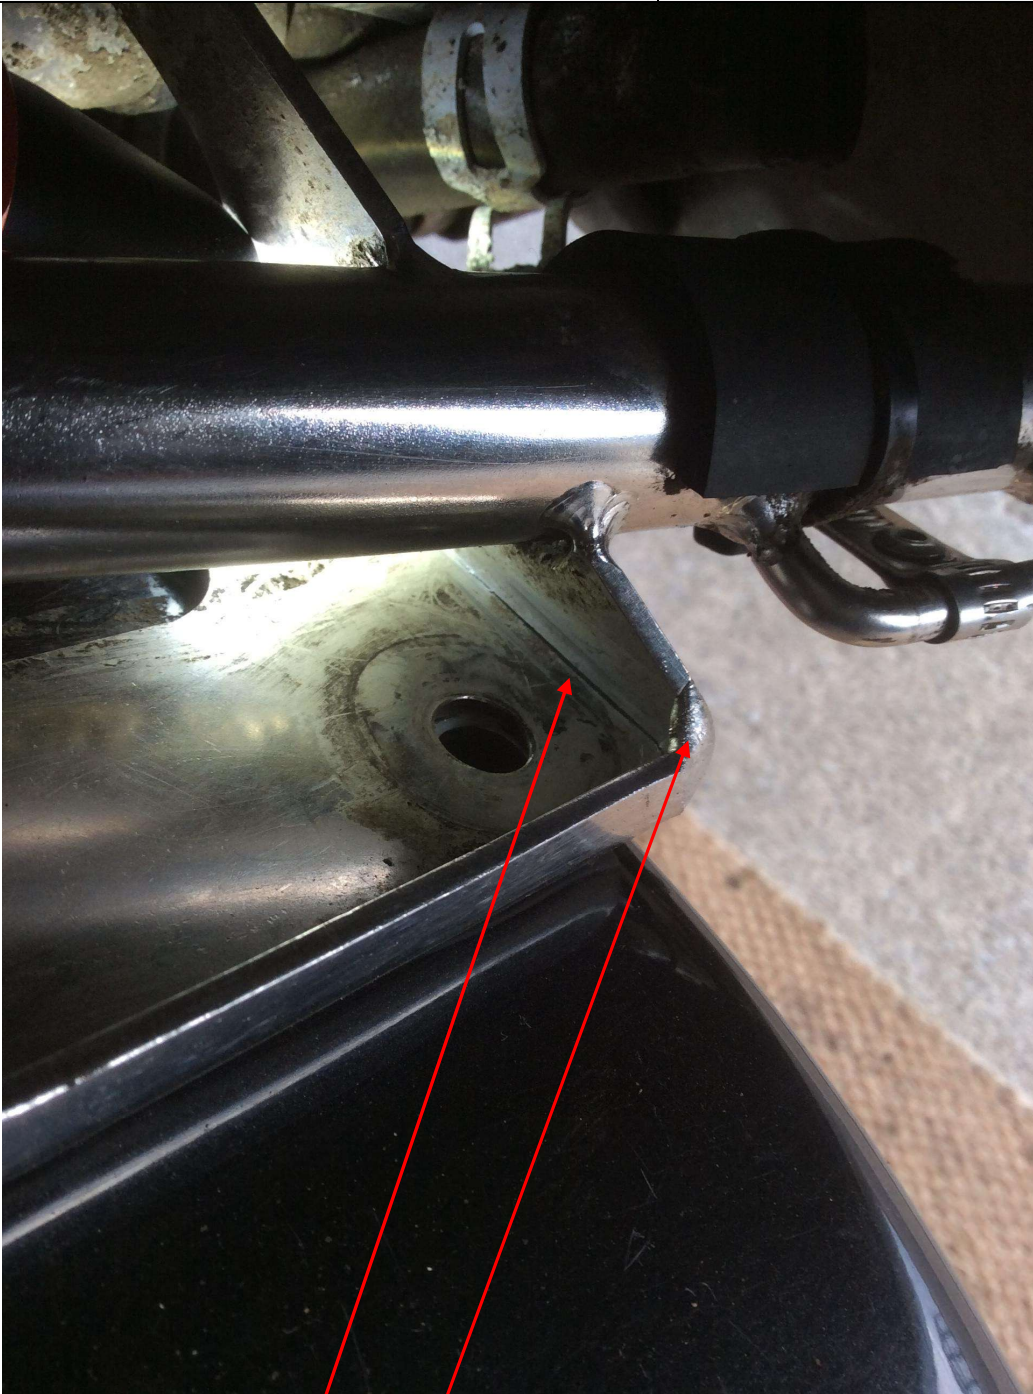
However, failure to find such issues could - especially in the suspension mounting bracket area - lead to subsequent significant bracket distortion and major repair work. SRA-025 covers the replacement of the entire suspension bow mounting bracket, a task that takes many days.

View of crack in the leading edge of the folded bracket area. This is visible from outside front of the bracket. Also check the corner bracket weld
