RotorSport UK Ltd

Service Information Letter

SIL-027

Subject: Effective airframe inspection

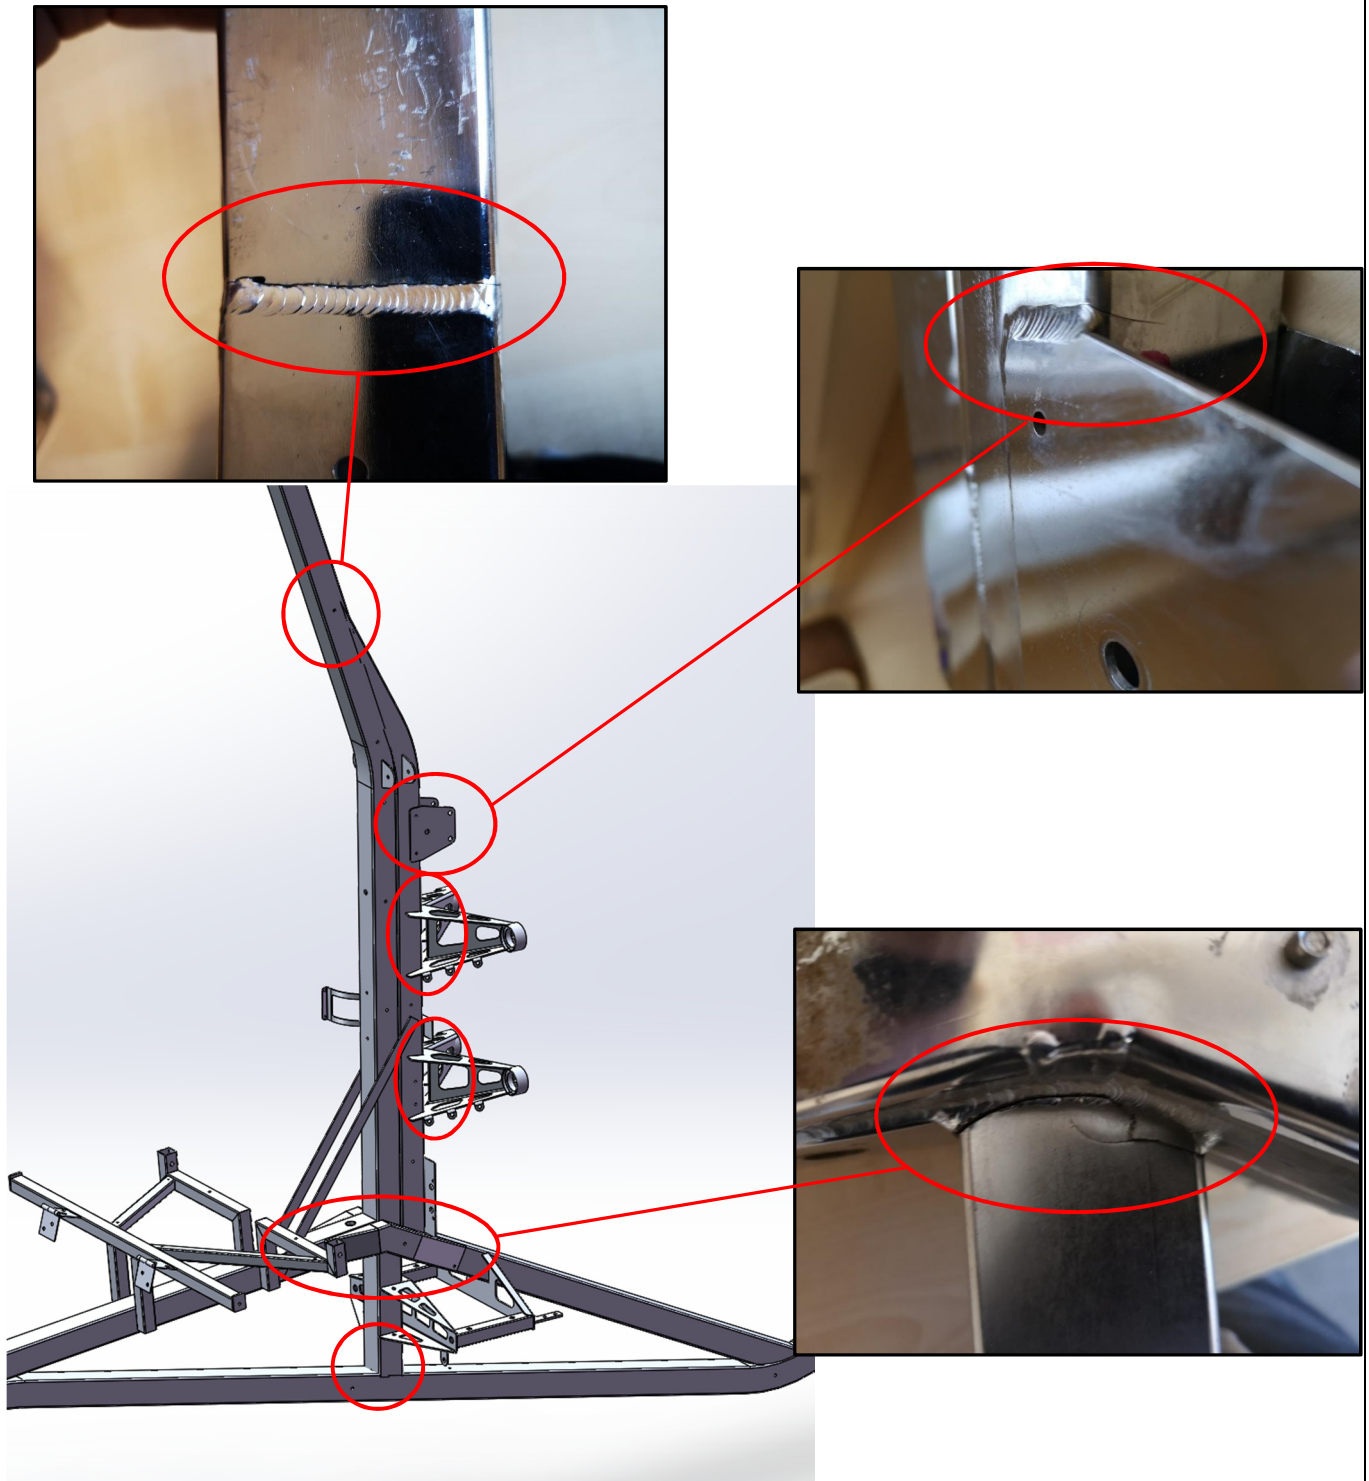
Fig. 1

These aircraft have now accumulated many years and hours in service, resulting in service issue reports submitted to AutoGyro. Within these AutoGyro has been advised of cracks in the mast root, and the weakening of this area leading to cracks in the upper weld area of the rear strengthening tube, and pre-rotator gearbox mounting plate attachment to mast area.

They are long term fatigue based, dependent on operational usage, and controlled by the 100hr service inspection interval. Repair is possible and is described in SRA-016 (mast) and SRA-019 (engine mounts).

The instances of cracking are few, however, failure to find such issues could - especially in the mast root area - lead to failure of the frame and subsequent unsafe condition.

Inspect the frame in accordance with the current 100hr service document AG-F-PCA-MT, paying particular attention to the areas noted below (Fig. 1).
