RotorSport UK Ltd

Service Information Letter

SIL-028

Subject: Rotor blade inspection guidelines

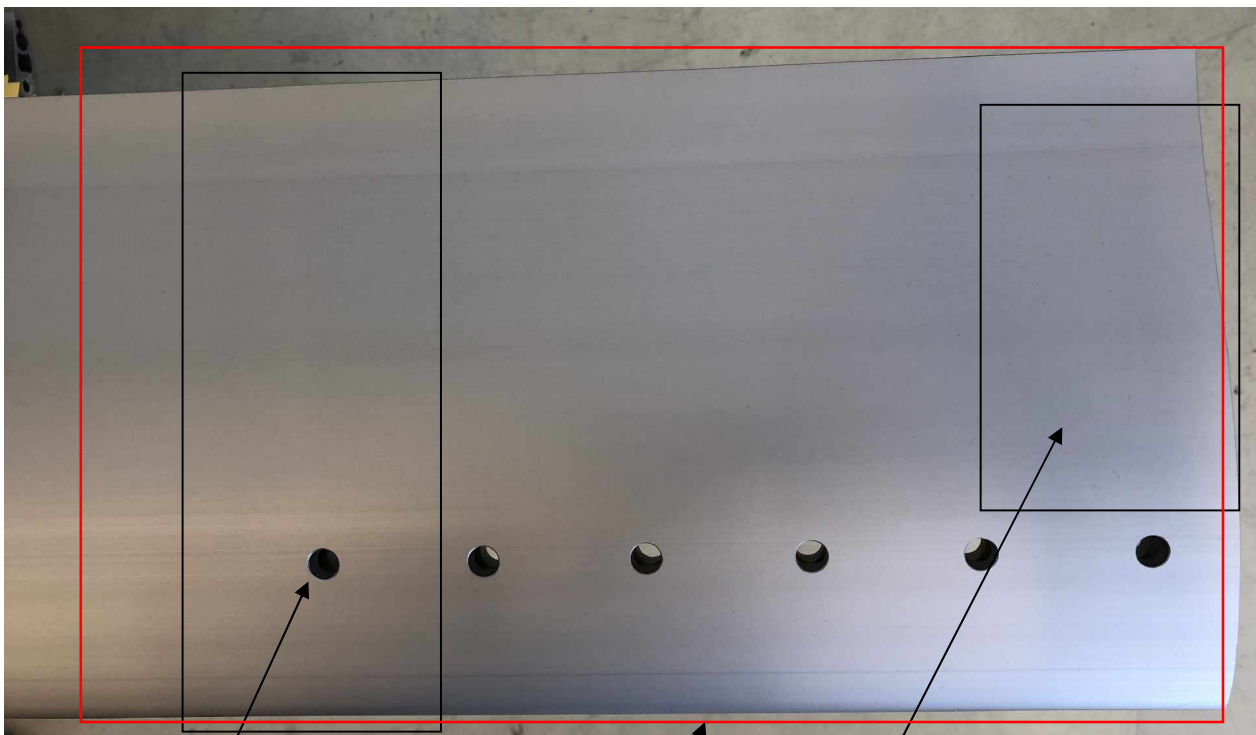
Outboard bolt hole area. Both upper and lower surfaces must be carefully inspected. No cracks, splits, dents or defects allowed +/-100mm either side of this hole.

No bending of the blade in any plane permissible in this area.
See SB-034 for RotorSystem I.

Area of possible crack in upper surface. Inspected either during strip down, or by removing the inner end cap and viewing in side the extrusion end with a bright lamp. See later note and photos.

The entire root area connection to the hub bar is of importance. Holes must be clean and free of burrs and corrosion. Fretting between the clamp profile (that sets the angle of blade incidence to the hub) should be minimal and not rubbing into the blade surface. Light damage to the trailing edge area, rear of the clamp profile, is permissible.

View of the top side of the rotor root (RSII, 6-hole attachment. The same applies to this area on the 9-hole attachment).

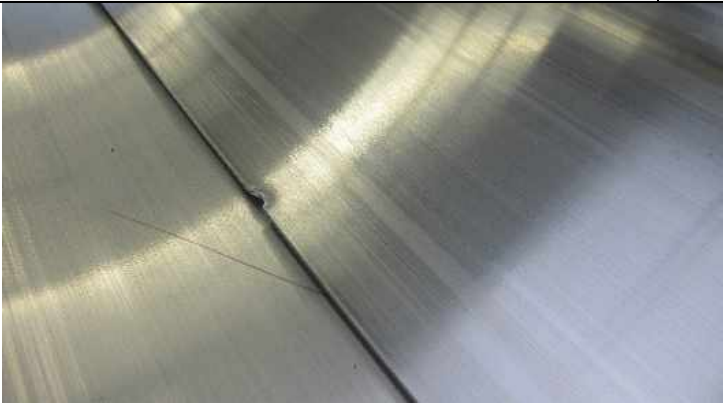
Trailing edge damage.

The photo shows an example of trailing edge damage. A ding in the trailing edge may be flattened out and the rotors continued in service provided that the ding does not cause a fracture into the inner part of the extrusion, and is not within 1m of the hub bar connection.

Small damage resulting in a light bend (1-2mm, typically at the rotor tip) may be straightened carefully to the same profile as the rest of the blade section. More damage must be discussed with RotorSport or AutoGyro technicians.

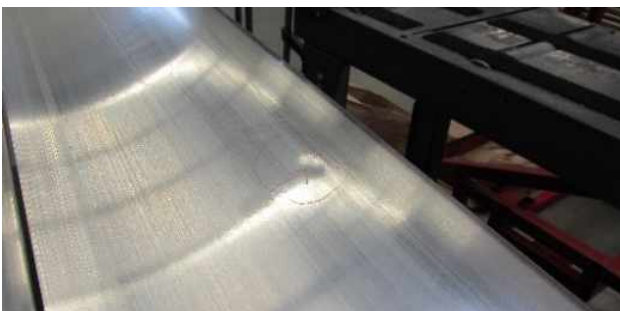
Leading edge damage.

Occasionally a stone or other foreign object enters the rotor disc whilst spinning, resulting in a dent in the leading edge, or in the blade surface. The leading edge is solid aluminium of significant thickness. Small dings can be dressed out only to the basic blade profile. Filling is not permitted. Significant dings within 2m of the hub bar are potential stress raisers and damage left in service must be carefully considered by the inspector for the level of risk. If in doubt, contact airworthiness@auto-gyro.com.

Dents in the upper or lower surfaces (such as the photo above) more than 1m from the hub bar up to 10mm in diameter are unlikely to cause a stress raiser and may be left in service and monitored by the user.

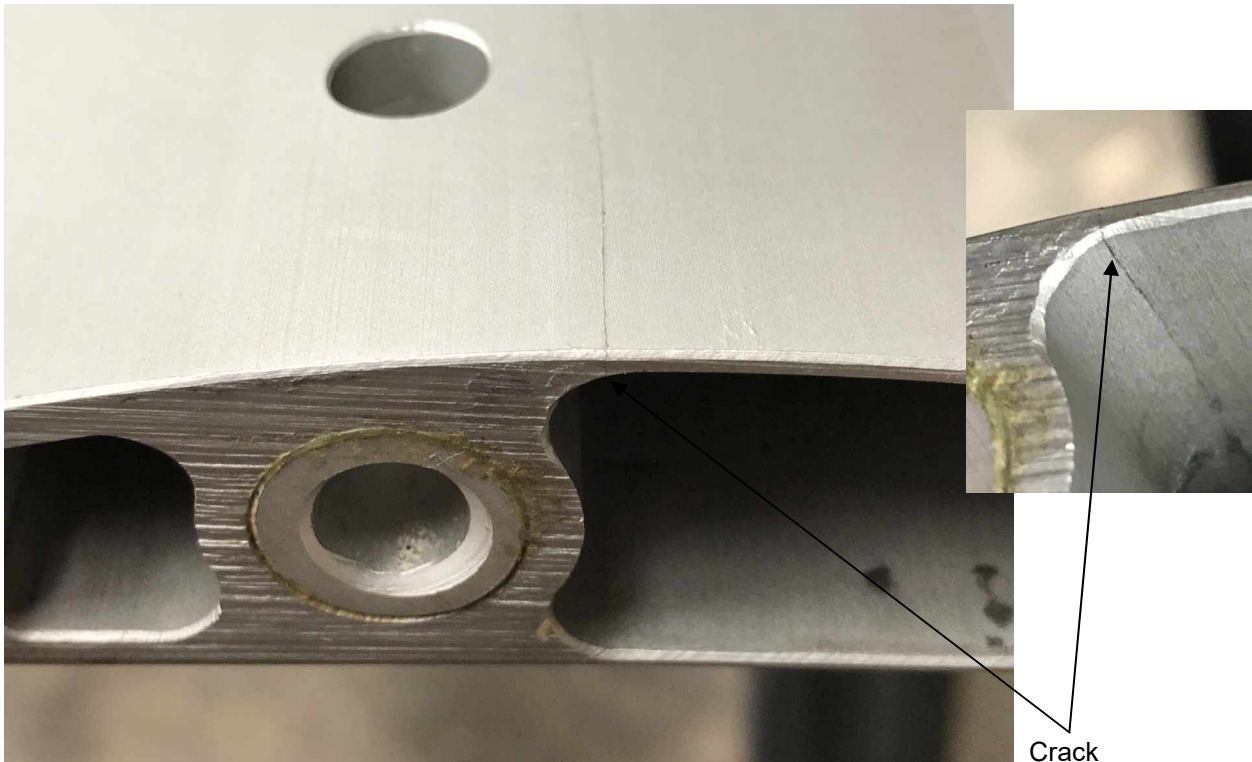
Longitudinal blade root crack, adjacent to bolted area.

The presence of such a crack can be easily inspected by removing the blade inner end cap, and viewing with a bright torch.

Photo of a longitudinal blade root crack, and inset a photo taken viewing from inside the blade with the inner end cap removed.
