Service Repair Request and Evaluation/Approval

Repair No. and Issue: SRA-020 Iss2
Calidus Mast bracket cracks

Aircraft type
Calidus

Aircraft serial No. RSUL/CALS/005
First application: G-YROZ

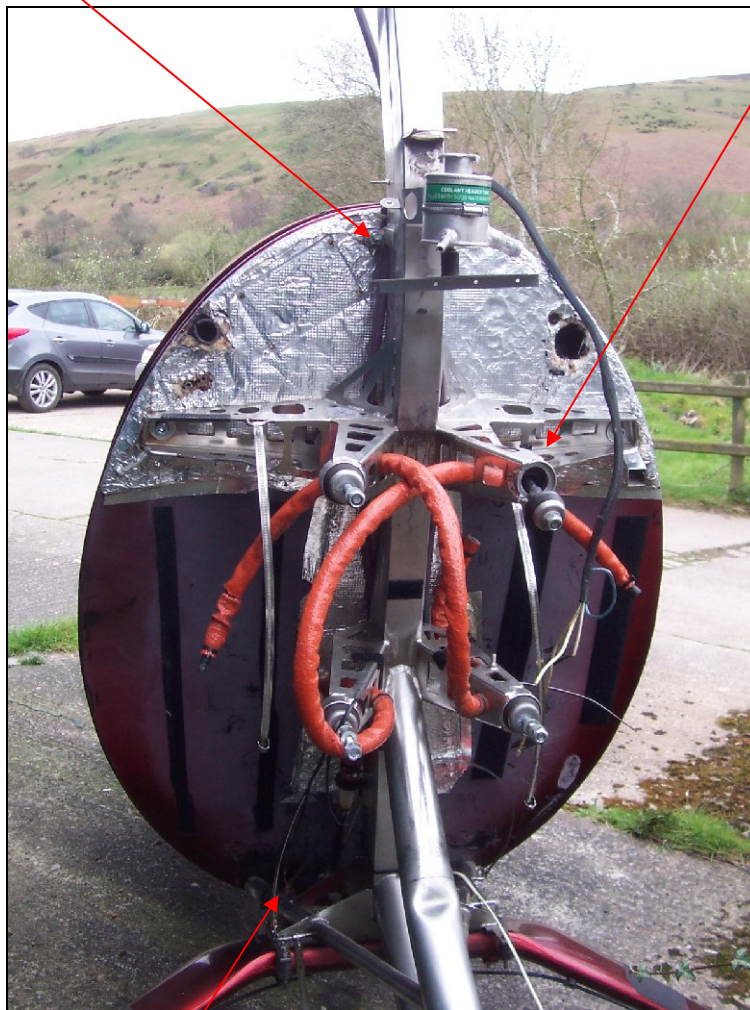
Calidus G-YROZ was found to have small cracks in the welds attaching the uppermost body mounting brackets to the vertical mast tube. This SRA-020 describes how to repair these cracks and reinforce the weld to prevent recurrence. It is considered a MINOR repair as there is significant redundancy in the mast-to-body mounting (8 bolted locations)

2-off Upper mounts

4-off central mounts

2-off lower mounts

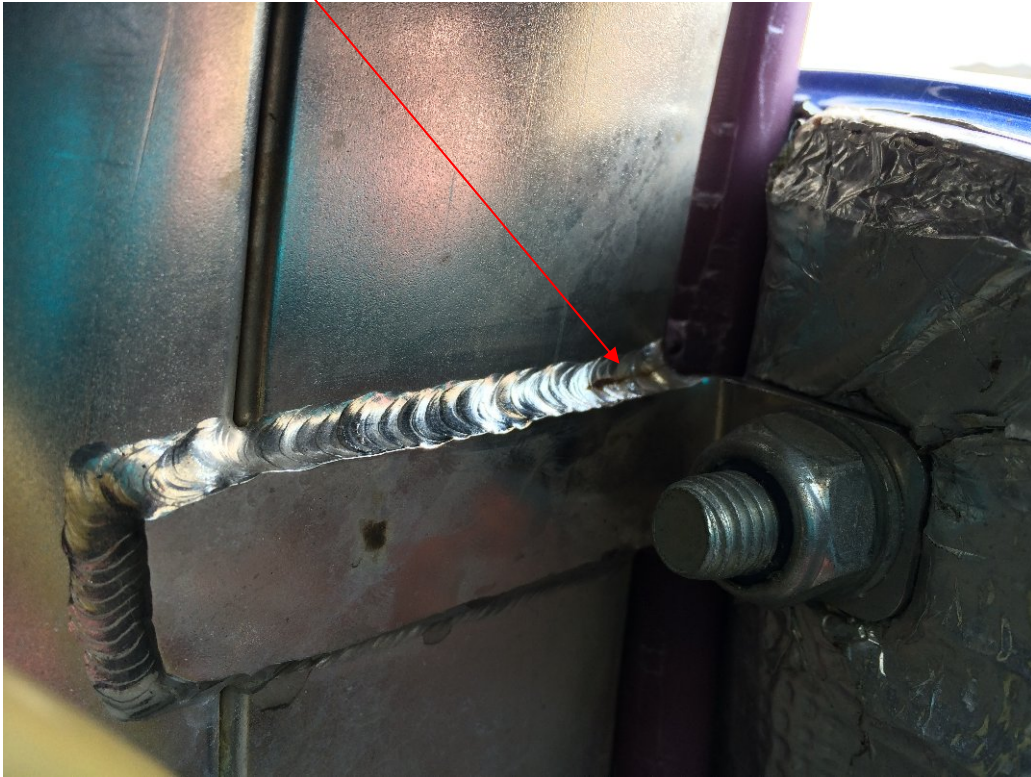
Crack in right-hand bracket

Limitations on implementation The cracks must not have propagated more than 33% of either weld length (i.e. max crack length 22mm) Welding must be carried-out by a welder approved by RSUK/CAA
Approval statement. The technical content of this document is approved under the authority of the UK CAA Design Organisation Approval Ref: DAI/9917/06.
Tooling required. Conventional hand tools and TIG welding equipment only
Weight and balance. Not affected
Manuals affected. None affected
Previous modifications affecting this SRA. None
List of materials required to complete this SRA: Weld filler rod only
List of components required to complete this SRA: None
Interchangeability: Not applicable
Parts disposition: Not applicable
Accomplishment instructions/details of the repair: <ol style="list-style-type: none">1) In order to create sufficient space for access the body and airframe must be separated slightly. Park the aircraft on level ground and remove the engine cowlings as described in AMM RSUK0061. Remove the rear seat cushions and ease-back the fabric trim from the bulkhead as required. Release the four fuel-tank straps a little to avoid straining the fuel tanks. Release by a few turns the 8 fasteners securing the body to the airframe, more so at the upper fasteners than the lower ones. Place a suitably padded trolley jack under the body and carefully lift the aircraft so that the upper mounting points separate sufficiently for access. Whilst moving the body monitor the control tube aft bearing (fitted centrally at the rear of the aircraft). If any strain is evident the fastener should be slackened. (Note: if this is done then on reassembly it must be removed to allow fresh Loctite 243 to be applied)2) Remove the air-redirection plates, disconnecting the coolant pipe as required3) Release the cable-ties securing the push-pull cables to the mast and move the cables clear of the working area. If necessary the cables must be disconnected from their mountings in order to move clear – mark accordingly to ensure correct set-up on reassembly4) Release the cable-ties securing the wiring harness to the mast and move the harness clear of the working area

- 8) Using a Dremmel-type tool with small grinding wheel (typ 0.75mm thick) progressively grind-out the length of the crack. Expose, **but do not grind into** the mast wall. Remove all grinding debris and clean-up with Amberclene LO30. Arrange inspection of the exposed mast wall in the area of the crack by a qualified inspector using a dye-penetrant process. If there is no evidence of a crack in the mast wall then remove the process deposits and proceed as below. If any crack is evident or there is any doubt, do not proceed but refer to RSUK.

- 9) Weld-up each prepared crack in one continuous pass (see below for welding requirements)
- 10) Working behind the bracket make a vertical fillet weld between the bracket and the mast section (both sides of aircraft)

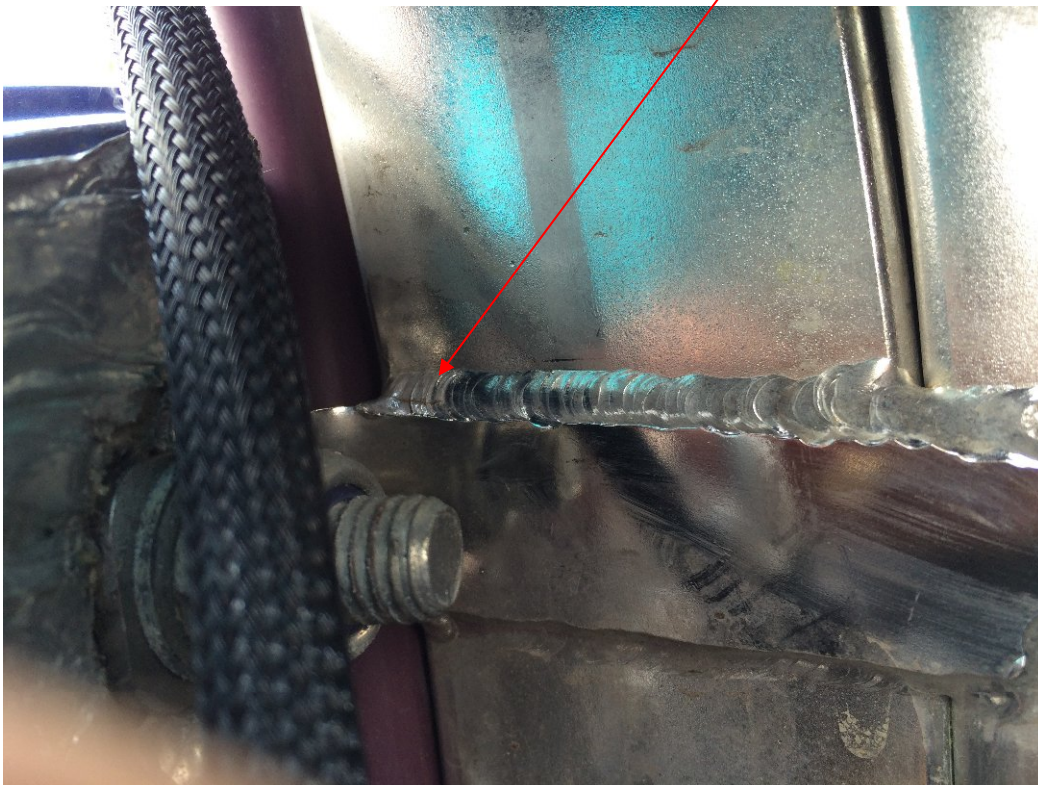
Crack in left-hand bracket
