## RotorSport UK Ltd Service Bulletin

SB No.: 048 Iss1	CCAR No.: None	Classification:		
		OPTIONAL		
Aircraft type & model (applicability)	Aircraft serial Nos effected	OF FIOI ALL OF		
Deterfue till Celline		DECOMMENDED or		
RotorSport UK Calidus	RSUK/CALS/001, 002, 003	<b>NECOMINIENDED OI</b>		
		MANDATODV

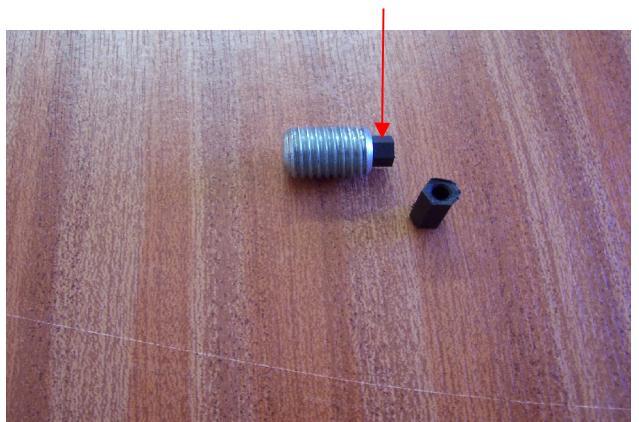
The rudder cables of Calidus aircraft exit the keel-tube through two M12-threaded steel inserts. To prevent the risk of long-term wear of the cable strands due to rubbing on the bore of these inserts two small nylon bushes may be fitted. These are easily fitted without any dismantling, provide a visual reference for wear assessment and may be readily replaced.

## Circular groove is here

- 2. Use an artists paintbrush dipped in solvent to clean the hexagonal bore of the M12-threaded insert and the adjacent female thread in the control-tube fitting.
- 3. Identify the split in the nylon bush <u>opposite</u> the axial machined groove. Using a small piece of thin metal lever the split of the bush open sufficiently to pass over the cable. Taking advantage of the leading-edge chamfer in the bush fit it over the cable with the circular machined groove outboard of the M12-threaded insert. Push the bush home.

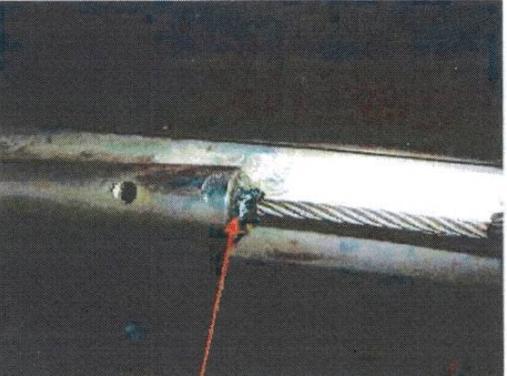
View of insert's hexagon socket and control tube's female threads
