Customer Information 01/2011

Modification of an Electrical Resistor for the IVO Propeller

MANDATORY

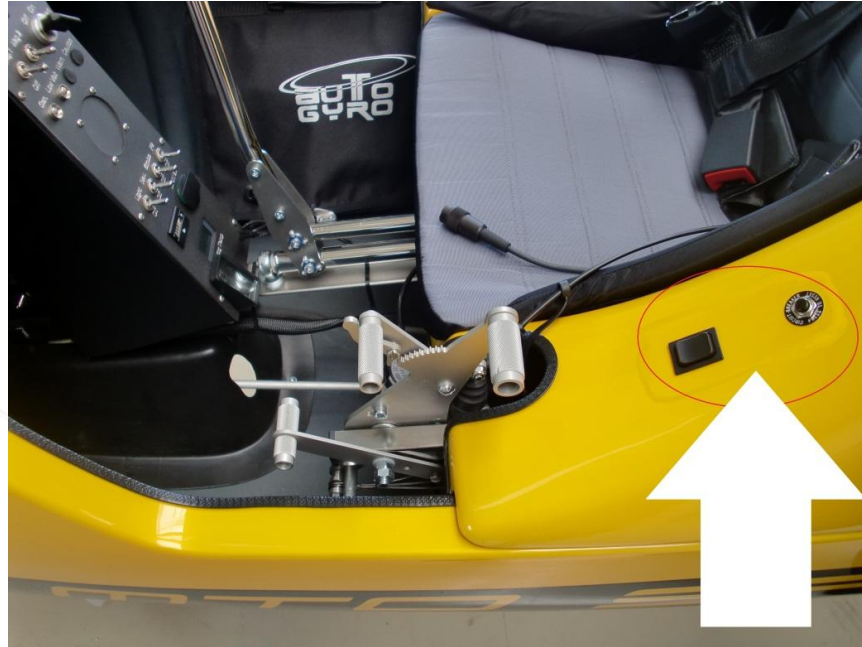
Pic 1

5. Secure rotor system with tie-down bag
6. Disconnect and isolate the minus pole of the battery. For Calidus: remove the lower right engine cowling.
7. Push the IVO adjustment switch out of the cockpit or seat surround, see pictures 1, 2 and 3

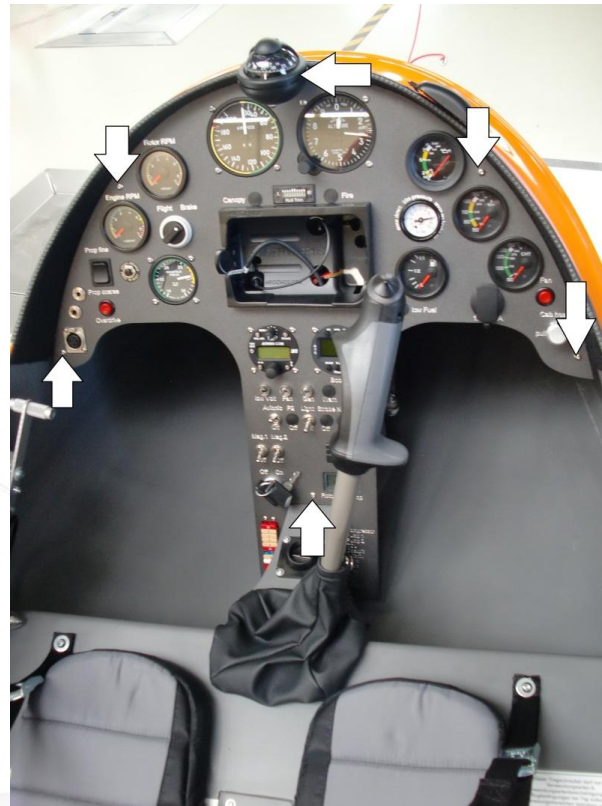
Pic 4

8. For the Calidus, if the adjustment switch is not able to be pushed out then it has been fitted using heat glue. In this case the cockpit panel must be tilted back for access. To enable this the six cockpit fastening screws must be removed, see picture 4

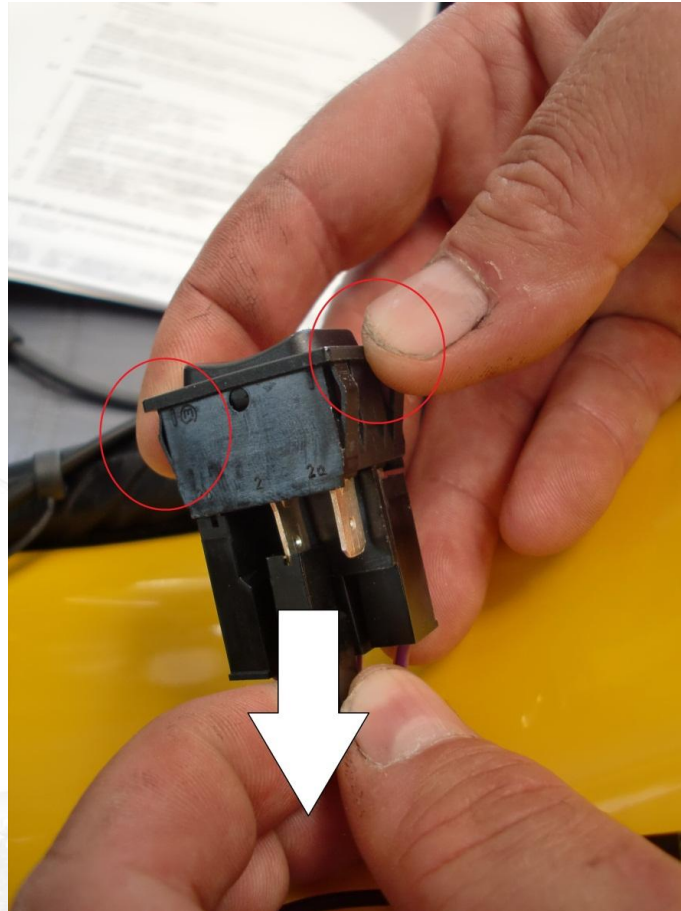
Pic 5

9. Remove the wires from the old switch, see picture 5. Ensure that the wires are removed by pulling on the plastic housing and not the wire
10. Remove the wires from the circuit breaker, see pictures 6, 7 und 8. Ensure that the wires are removed by pulling on the plastic housing and not the wire

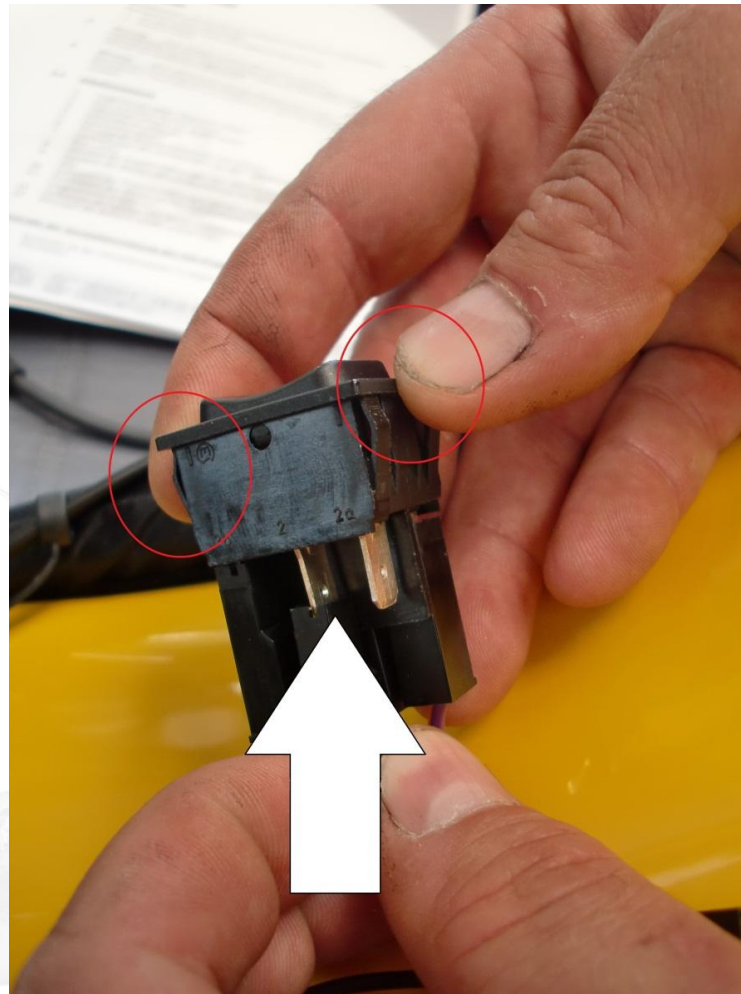
Pic 9

11. Connect the wires with the resistor to the new switch in the same positions as they were removed from the old switch, picture 9
12. Feed the wiring through the opening and push the switch back into position in the cut-out, picture 10

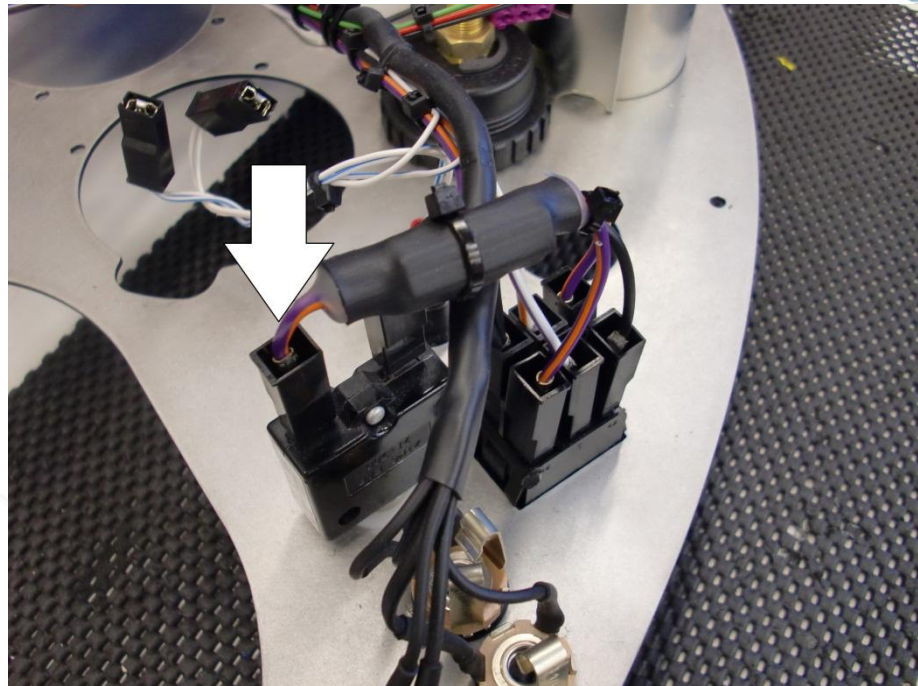
Pic 11

13. Connect the wires with the resistor to the circuit breaker, see pictures 11 and 12.
14. Re-connect the minus pole of the battery
