AG-SB-2017-01-C-EN – Protection of the measuring lines of the shunts

Service Bulletin

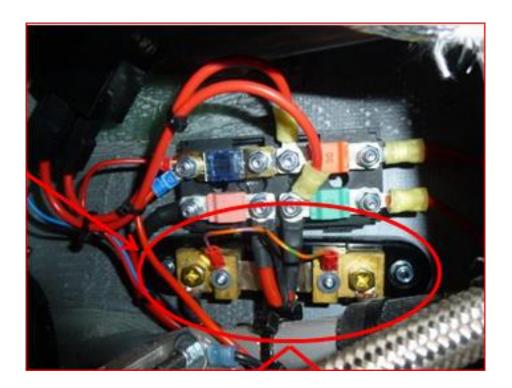
It has been found that the two Dynon shunt current measuring lines require additional safety fuses (see Fig. 1).

Fig 1: Shunt, old installation

- 1 Get access to the components by removing the engine cowlings, and inner firewall (Cavalon)
- 2 Disconnect the earth connection of the battery where convenient for access.
- 3 Disconnect both 0,352mm cables from the shunt (see fig 1).
- 4 Remove the ring terminals from the cables, leaving a length of bared cable approx 5mm long.
- Insert the bared cable into Article 44243, and crimp in place. Ensure that the crimps are secure, and then shrink the shrink sleeve with a hot-air gun.
- 6 Reattach the cables to the shunt, and tighten the nuts securely.
- 7 Reconnect the battery where disconnected.
- 8 Securely refit any removed access panels, firewall and cowlings.

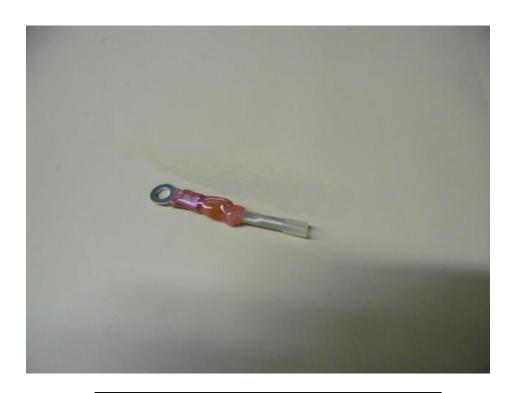
Fig 2: part no. 44243 - Shunt wiring protection

Retrofitting of two additional fuses (In Wire fuse suitable for the cable cross-section).

Fig. Pos. Description PC PIT Remark
2 Shunt wiring protection 1 44243

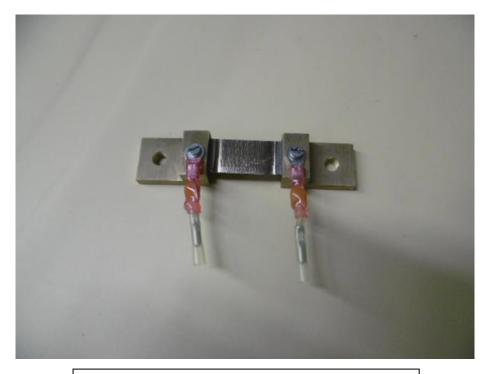
Fig 3: Shunt, new installation

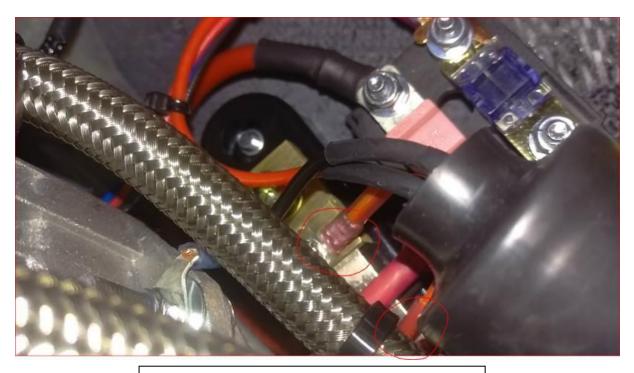
Fig 4: Shunt, new Installation
