RotorSport UK Ltd Service Bulletin (Permit)

Title: IVO-prop gearbox overhaul		
SB-125 Iss1	Related documents Modification: MC-276, -294, -318, -323 CCAR No.: CCAR-64, -66, -70	Compliance Category: OPTIONAL or RECOMMENDED or MANDATORY
Applicability		
Aircraft type & model: Any RSUK type fitted with IVO-prop DL3-68 VP-propeller	Aircraft serial Nos. affected: Any RSUK type fitted with IVO-prop DL3-68 VP-propeller	
The maintenance manual to be referenced is this stated or subsequent issue.		MT-03 RSUK0012 Iss 10 MTOsport RSUK0044 Iss 9 Calidus RSUK0061 Iss 7 Cavalon RSUK0288 Iss 5
<p>This form is the response from RotorSport UK Ltd either against a problem found in the product in service requiring a containment or rectification action, or as service information for aircraft modification incorporation. For help, contact RotorSport on 44(0)1588 505060, or email compliance@rotorsport.org.</p> <p>The technical content of this document is approved under the authority of the UK CAA Design Organisation Approval Ref: DAI/9917/06</p>

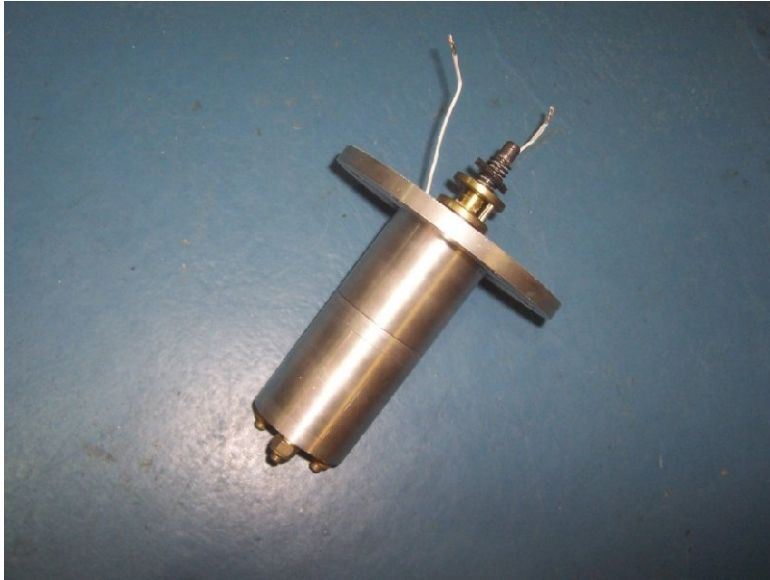
Motor/gearbox assembly removed

1. Position the aircraft on level ground and apply the parking brake/chock the wheels. Remove engine cowlings for access to the propeller hub (see aircraft AMM)
2. Verify that the two Mag-switches and the Master Switch are OFF
3. Using a suitable marker pen or adhesive tape mark the spinner/propeller/hub relationship to ensure precise replacement (particularly the blades, which are numbered 1,2,3)
4. Remove the spinner
5. Remove the brush carrier and tie to one side
6. Remove the propeller complete by releasing (progressively) the six 3/8" AN hex bolts/nuts and transfer to the workbench. DO NOT REST THE PROPELLER ON THE BLADE TIPS.
7. Making reference to the propeller manual RSUK0325 remove the three blades then the motor/gearbox assembly

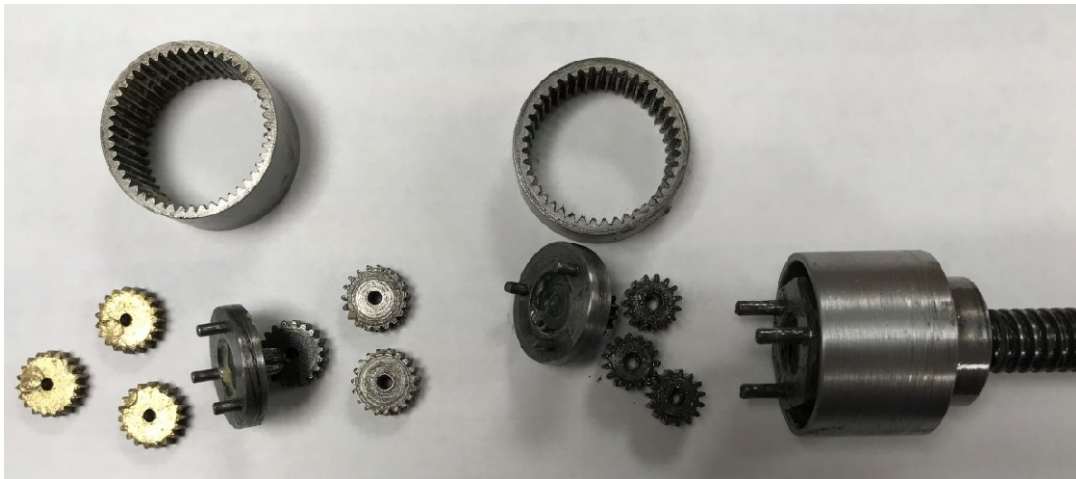
10. There are three layers of gears. During dismantling and cleaning be sure to keep the layers together as a set.

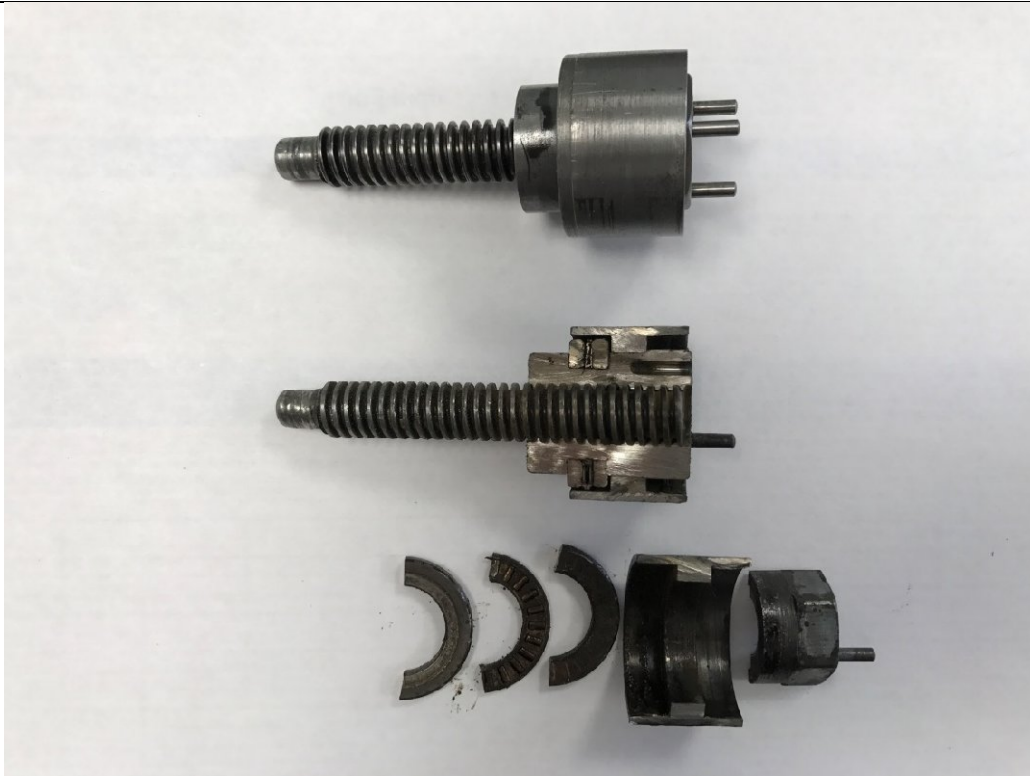
11. Using petrol or Amberklene LO30 solvent (RSD4655) thoroughly clean all grease from the gearbox assembly and motor mounting plate.
12. The leadscrew/nut assembly cannot be dismantled so clean as an assembly and use compressed air to remove any debris. Ensure that the parts spin freely and smoothly. For information a sectioned view of this assembly is shown below
