Title: Cavalon 915 Lower Engine Cowling Heat Protection		
AG-SB-2020-05-B-EN		Compliance Category:
Applicability		
Aircraft type & model: AutoGyro Cavalon	Affected Serial number(s): All Cavalon fitted with the Rotax 915iS engine	A – MANDATORY B – RECOMMENDED C – OPTIONAL
The maintenance manual to be referenced is this stated or subsequent issue.		As per AutoGyro website
This form is the response from AutoGyro GmbH either against a problem found in the product in service requiring a containment or rectification action, or as service information for aircraft modification incorporation. For help, contact AutoGyro on 49(0)5121 88056-00, or email airworthiness@auto-gyro.com .

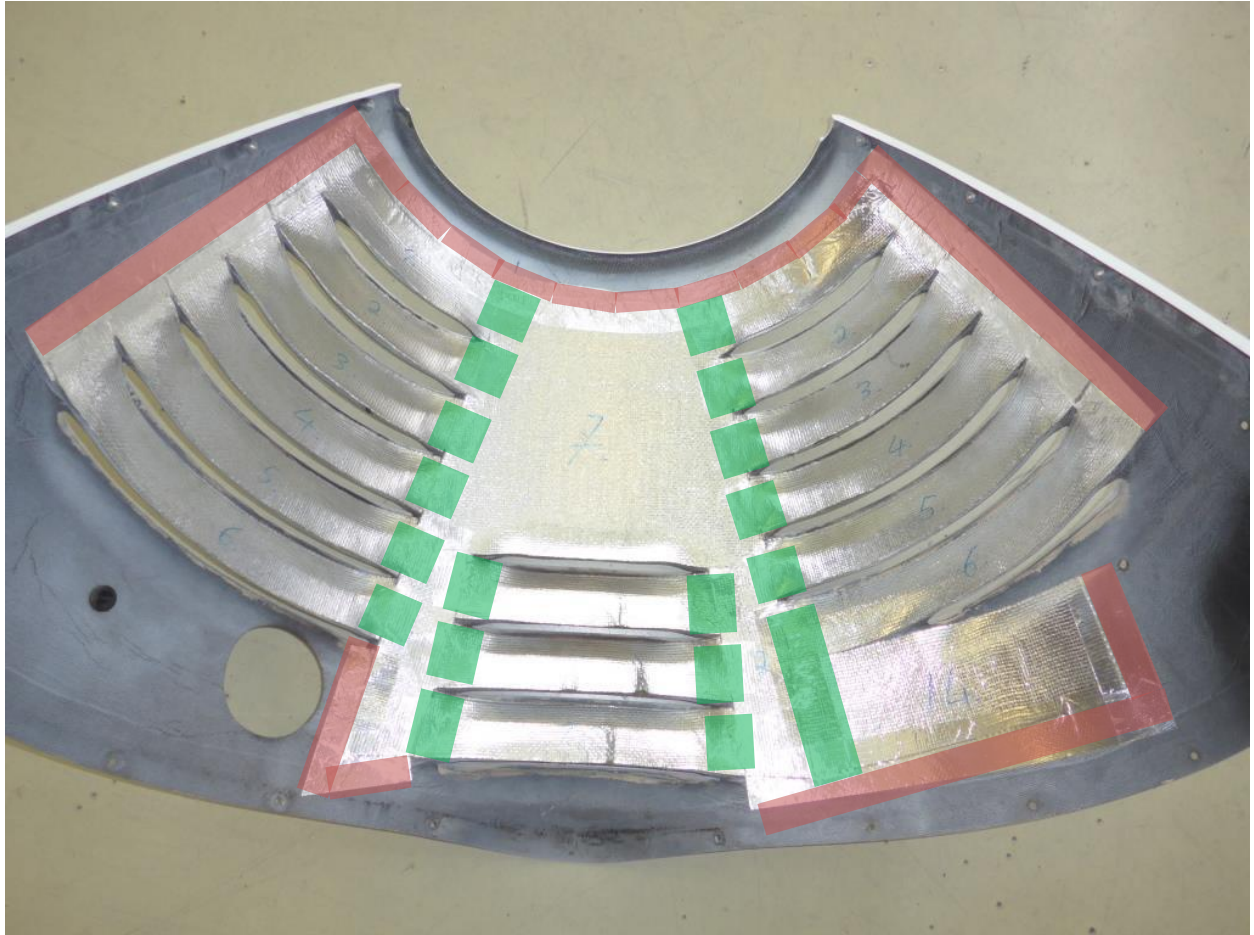
(Pic. 2)

5. Using an appropriate medium, smooth the area of the interior surface of the cowling where the 50mm alu tape is to be applied (Pic. 2 red areas) and de-grease using silicone remover 34081 or similar. **If this is not carried out, it is extremely likely that the tape will detach from the cowling after a period of time.**

6. Apply the 50mm alu tape to the edges of the 50mm alu tape at both the previously smoothed areas (red areas) and the green areas shown in pic 2.
7. Re-fit the lower and upper engine cowlings.
