RotorSport UK Ltd Service Bulletin

Title: Cavalon rear skid-plate		
SB No.: 065	Related documents MC No: 241 CCAR No.: None	Compliance Category: OPTIONAL or RECOMMENDED or MANDATORY
Applicability		
Aircraft type & model: Cavalon	Aircraft serial Nos. affected: Any prior to RSUK/CVLN/005

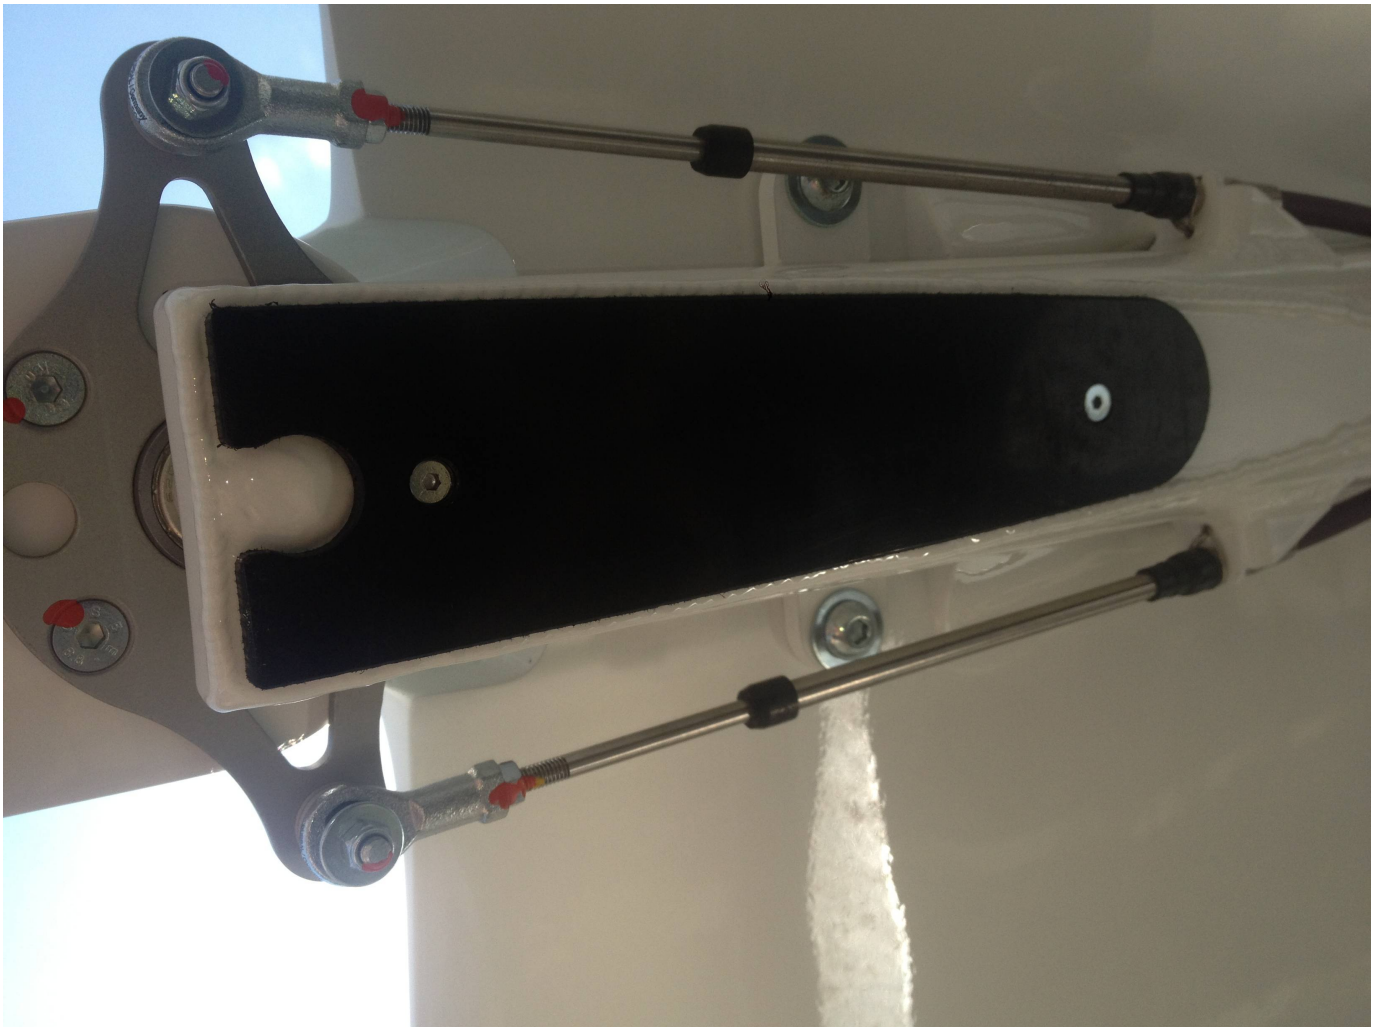
Skid plate installed

Assemble the skid-plate to the aircraft using two M4x12 countersunk screws and Loctite 221. Tighten only until the plastic plate is firmly attached. Do not crush the plate.
